# Assessment of Earthquake Damage at the Washington National Cathedral

Matthew C. Farmer  
Kelsey E. Sheridan  
Jacqueline Devereaux

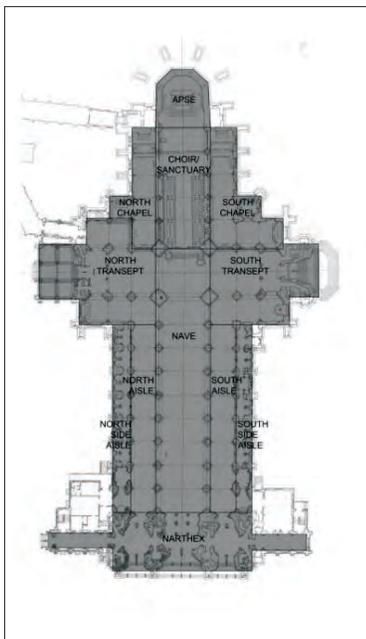
Fig. 1. The Washington National Cathedral, constructed 1907–1990, 3101 Wisconsin Ave NW, Washington, D.C. 20016.

An earthquake on the East Coast of the United States is not an event to which most people would have given much thought prior 2011. But on August 23, 2011, the United States Geological Society recorded a 5.8Mw (moment wave) earthquake with its epicenter in Mineral, Virginia, 84 miles southwest of Washington, D.C. This event affected numerous structures in the area, many of which were registered historic places and landmarks or were constructed using historic materials and methods. Many more unreinforced masonry structures were damaged than modern buildings constructed of concrete or steel. The Washington National Cathedral, perhaps the largest unreinforced masonry structure in the Washington, D.C., area, suffered significant damage (Fig. 1).

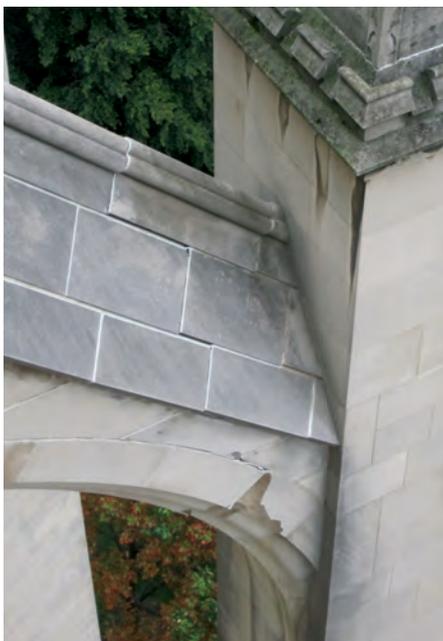
Fig. 3. Typical damage to a turret.

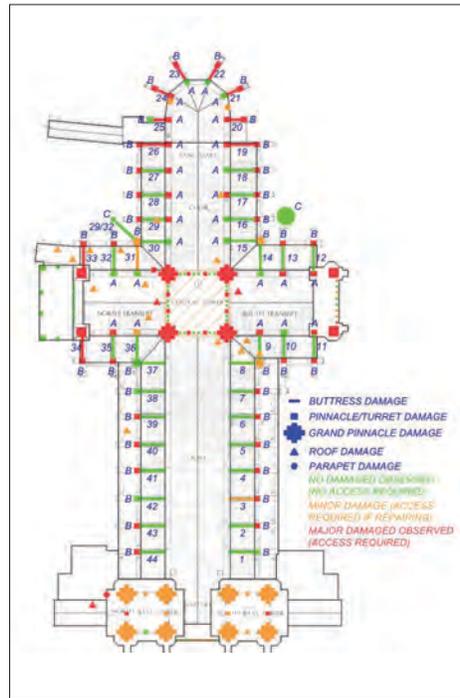
Fig. 5. Plan showing damage distribution.

As illustrated in Figure 5, the damage documented was further sorted into three categories based on the severity of the damage and on the extent of in situ stabilization and repair or removal and reconstruction that was required.

The first category of damage (shown in green in Figure 5) was identified as “no damage”; this term identified those areas where no visible damage was observed and therefore did not require any scaffolding or similar means of access for repair. The second category (shown in orange) was identified as “minor damage”; it consisted of limestone elements that had visible damage at the exposed surfaces of the stone but remained materially intact and fully engaged to the structure. Repair of these elements, which in several locations included surfaces and features that did not contribute significantly to the overall architectural expression of the cathedral, could be undertaken on a more voluntary basis as funding became available. However, mobilization and erection of pipe-scaffolding or similar equipment would be required to access these locations.

The final category (shown in red) was identified as “major damage” and included missing or otherwise visibly unstable elements that remained a potential fall-hazard or damage considered to be structurally insignificant but visually important and therefore in need of more immediate repair. Areas in this category required pipe scaffolding and/or the use of mobile cranes and hand-operated block-and-tackle devices to facilitate the removal, replacement, and resetting of large pieces of stone.

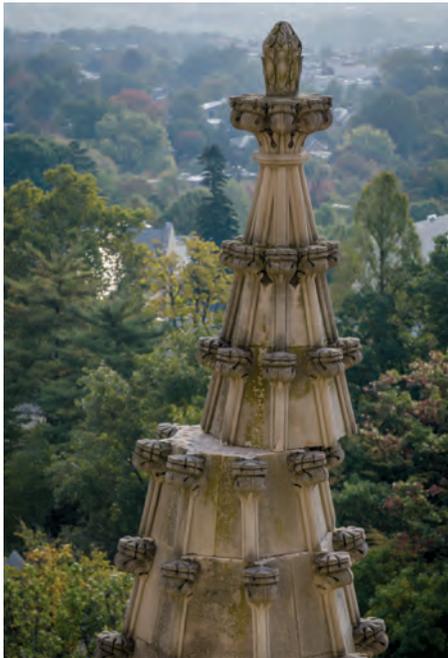
As the exterior assessment continued over the next several months, it became clear that some of the vertical facade surfaces included damaged elements whose stability was more difficult to assess (Fig. 7). Many locations of concern were directly above the entrances, which increased the risk to cathedral visitors. In order to reopen the cathedral to the public without overhead protection at the west facade, a close-range survey was undertaken in an attempt to ensure that any unstable stone fragments were identified and removed or stabilized in place. Specially trained preservation-engineering teams used rope access to perform a hands-on survey of the vertical surfaces above the main west entrance, including the west facades of the west towers and all facades of the central tower. Damage was documented on digital tablets loaded with scans of the original drawings and on overlay software that enabled photo and note referencing while the engineers were suspended from boatswain chairs (Fig. 8).

Fig. 7. Typical damage to a turret.

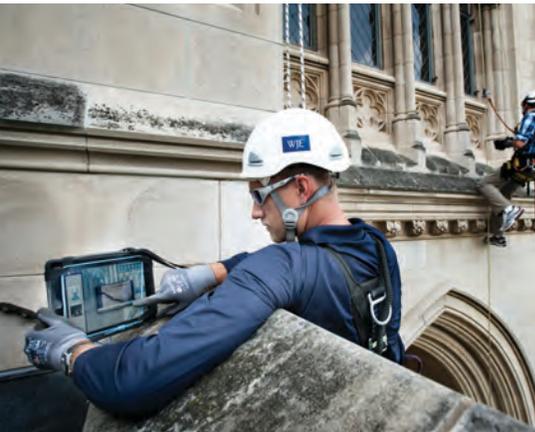
Fig. 8. Damage caused by earthquake being documented on digital tablets by engineers while suspended from boatswain's chairs.
