Conservation of the Hollow Tree in Vancouver's Stanley Park

HAROLD KALMAN AND LORNE WHITEHEAD

Vancouver's Hollow Tree, a 1,000-year-old western red cedar and major tourist attraction, faced removal but has been saved by a determined citizens' group in an innovative heritage-conservation project.

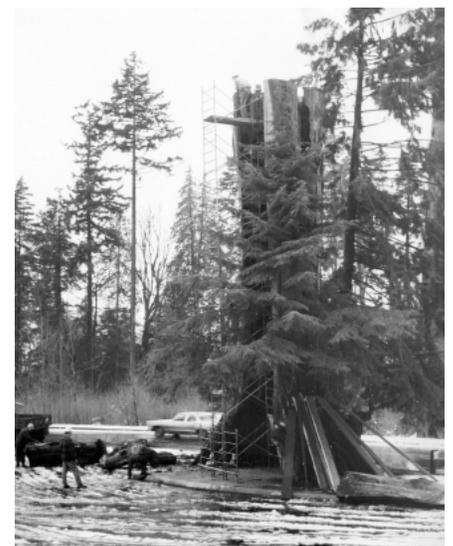
In 1965-1966, just after Typhoon Freda wreaked havoc on Stanley Park, the Park Board made a number of interventions to protect the Hollow Tree. It built a curb around the base of the tree to discourage motorists from driving into it and paved the adjacent parking area. About 2 feet of loose fill was placed around the base of the tree, raising the grade to the top of the curb. This action had the unfortunate effect of retaining rainwater in the fill, in contrast to the naturally well-draining hardpan below, and probably significantly accelerated the deterioration of the tree’s lower structure. Other interventions at that time included adding metal braces, cables, and plates as reinforcements and removing another 8 feet from the top of the tree for perceived safety reasons (Fig. 3).¹²

Fig. 3. The Hollow Tree being topped, 1966. Note the two young hemlocks growing out of it. City of Vancouver Archives, 392 1012.

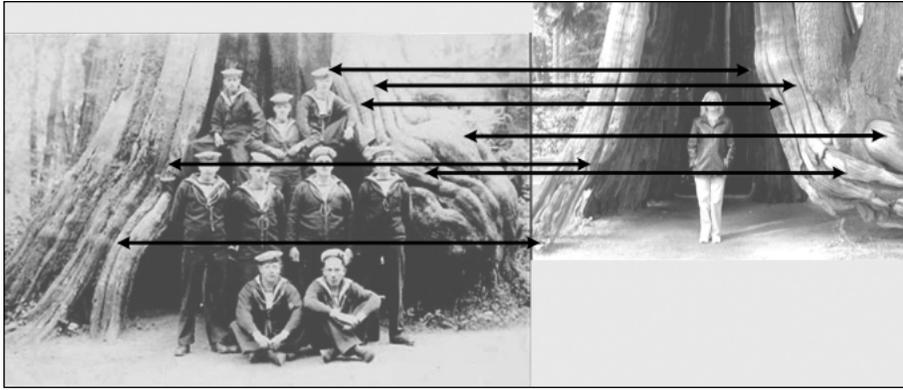
As the tree aged, its natural structural-support systems weakened. This condition was probably exacerbated by the loose fill placed around the base in 1965. The result was considerable deterioration of the underground structure of the Hollow Tree. It may have been this intervention that caused the tree to tilt eastward and slowly force the open (east) side to descend toward the ground. Comparison of photographs taken around 1920 and 1980 shows that approximately 3 feet (1 meter) of the trunk on the east side has disappeared from the bottom and that the diameter of the tree at the base is less than it was previously (Fig. 5).

Fig. 5. Photographs of the east side of the Hollow Tree, c. 1920 and c. 1980. The horizontal lines match the same features in the two photos. The lost material at the bottom required shifting the right photograph upward by the equivalent of about 3 feet (1 m). Composite photograph by Lorne Whitehead.

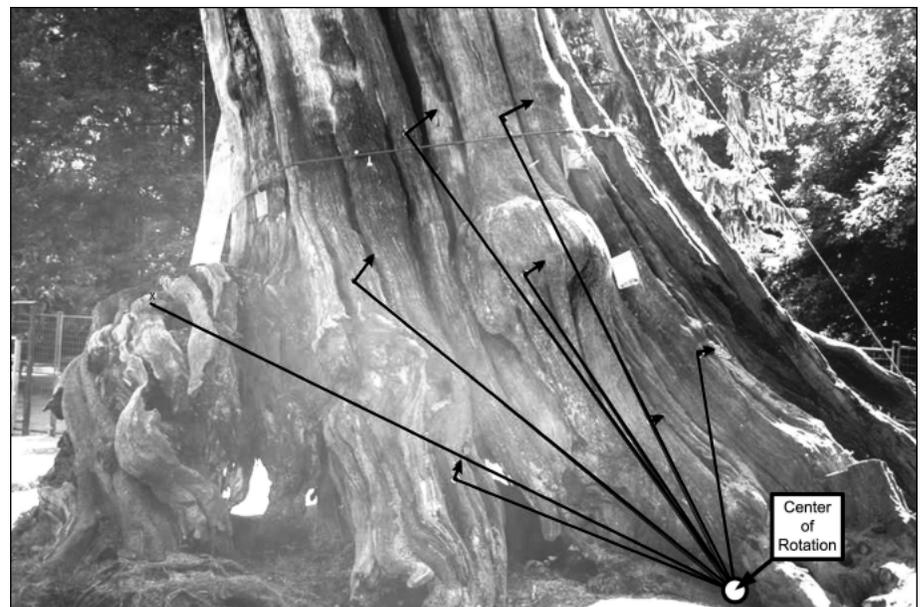
Fig. 6. This 2008 photograph shows the unstabilized position of the Hollow Tree, and the lines and arrows show the movement of the tree that resulted from the test displacement. Image by Lorne Whitehead.

In a final test, a hydraulic jack system applied pressure to a temporary support member, to achieve a displacement of about 6 inches (15 cm) at the midpoint of the structure. Digital photography and computer-analysis techniques accurately determined the movement of various points on the tree. It was found that the tree would preferentially rotate, as a single coherent object, around a horizontal axis near ground level and centered beneath it. Figure 6 shows the original position of the tree, and the superimposed lines and arrows show the movement of the tree that resulted from the test displacement. The only exception to this rotation was at the leftmost point, at the top of the burl, which did not move, showing that although the burl was adjacent to the tree, it was not structurally connected to it. The test also determined that the required force to cause such movement was less than 11.25 tons (100,000 Newtons), which is well within the capacity of available large cranes. This finding meant that returning the Hollow Tree to a vertical orientation was feasible.

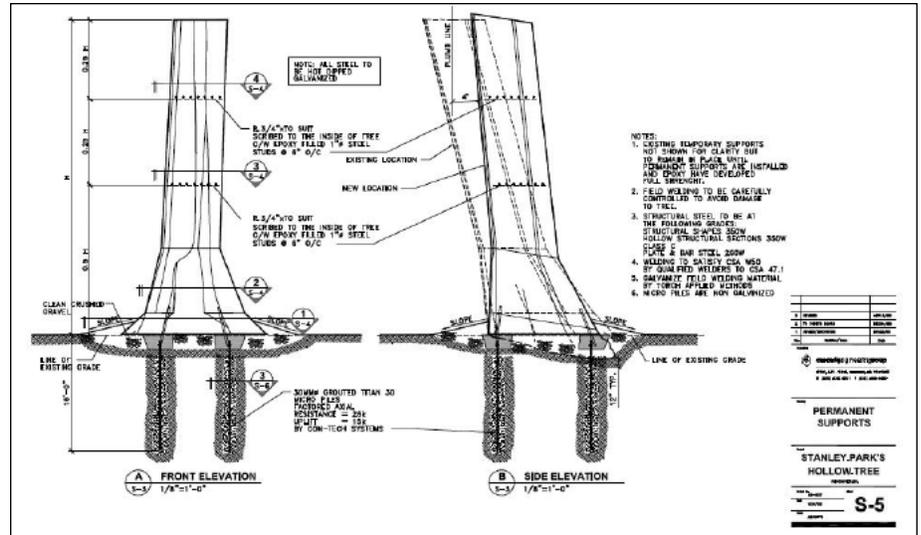
Fig. 7. Sections showing the micropiles, concrete pile cap, and major support frame, 2009. Drawing by Cascade Engineering.

Working according to these principles, a set of structural drawings was prepared by the engineers (Fig. 7). The design system comprised four basic elements, none of which was unusual in and of itself but which together comprised a unique solution to a problem that, to our knowledge, had not previously been encountered in this form in either professional engineering or heritage-conservation practice. These ele-

Foundation. The foundation system design called for 14 steel foundation micropiles, each grouted to a depth of 15 feet (4.5 m) in the glacial-till hardpan beneath the Hollow Tree. In other circumstances, a simpler alternative could have been to form a deep and broad reinforced-concrete foundation whose weight alone could provide sufficient stability against wind and earthquakes. However, in this situation it was not possible to remove the Hollow Tree to enable such major excavation. In contrast, because of the Hollow Tree’s open interior, it would be possible to employ handheld drills inside the tree in order to create the required holes into which the micropiles could be grouted to form, effectively, artificial roots. Topsoil was to be removed in a circular area around the tree approximately 40 feet (12 m) in diameter, but to a depth of only 1 foot 8 inches (50 cm), and then replaced with a steel-reinforced concrete pile cap that would encapsulate the top portions of the micropiles, each of which was to be topped with nut-locked connection plates. The strength of this foundation design would exceed the anticipated loads from possible weather-related and seismic events by approximately a fac-

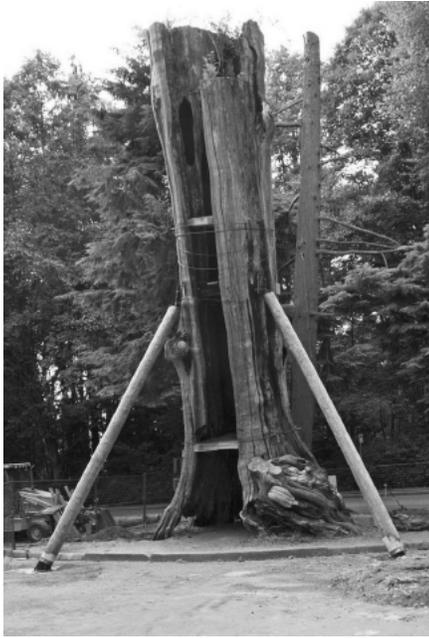
Fig. 8. The Hollow Tree supported by temporary braces, July 2008. Photograph by Harold Kalman.

Temporary support. We now know — but did not know at the onset of work — that the Hollow Tree was very close to falling over. Fortunately, the very first step in the conservation process was to install two 33-foot (10-m)-long, 1-foot (30-cm)-diameter temporary timber braces that spanned the installed foundation blocks to points approximately 16 feet (5m) above ground level, effectively forming a large tripod that would be stable, even if all torsion support from the ground were to fail (Fig. 8).

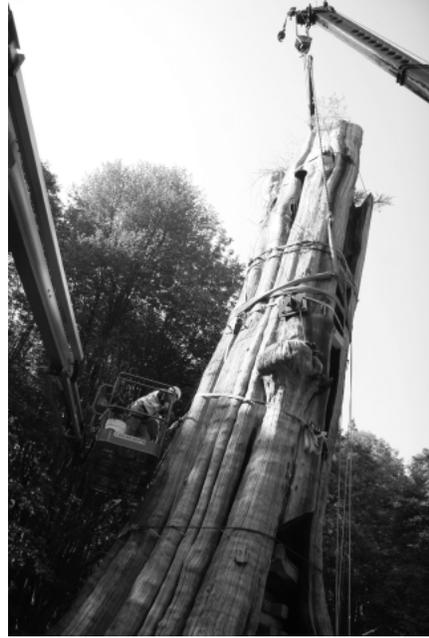
Fig. 9. The Hollow Tree being raised upright, June 11, 2009. Photograph by Amy Cameron.

Straightening. A large construction crane was used to apply an upward stabilizing force to the east side of the Hollow Tree, which enabled the timber supports to be temporarily removed. The crane then pulled it up further, and, as hoped and expected, the Hollow Tree achieved a vertical orientation (Fig. 9). The timber supports were lengthened so that they could reach their attachment points and were reinstalled to again temporarily stabilize the tree. The crane was then removed.

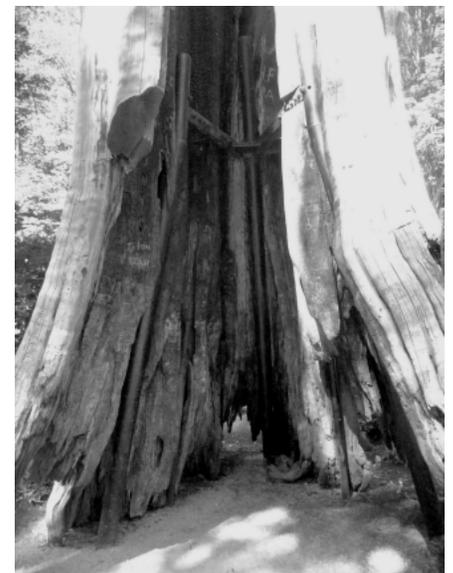
Fig. 10. The internal support frame, showing the tubular-steel uprights and the horizontal bridging elements, August 2011. Photograph by Harold Kalman.

Installing the support frame. The installation of the tubular-steel frame elements was done simultaneously with their attachment to the interior of the Hollow Tree, using the design methods described earlier. The installation process involved removal of small amounts of wood to allow a snug fit to the interior in a manner that did not attempt to

hide the support elements but that made them unobtrusive in this setting (Fig. 10). The support frame is painted black and is visually lost in the shadows; however, it is fully evident upon entering the tree. Ironically, one of the greatest challenges was in drilling the long bolt holes through the wood — the wood was much stronger and harder to drill than anticipated.

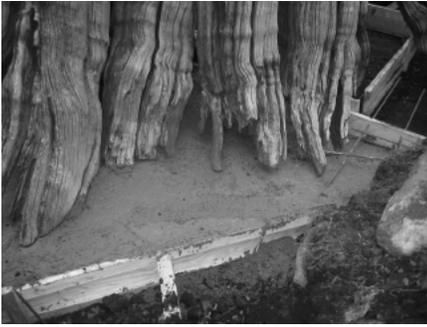
Fig. 11. A portion of the concrete pile cap, shortly after pouring, October 2009. Photograph by Lorne Whitehead.

Pouring the pile cap. Although critically important, the last step was also the least problematic: reinforcing steel was installed in the excavated region, also threading the tubular-steel support elements, and the concrete was poured, resulting in a smooth surface just below the level of the adjacent ground (Fig. 11). The only difficulty was that the confined geometry of the hollow tree and its surroundings limited access of the concrete truck and required very labor-intensive placement of the concrete.

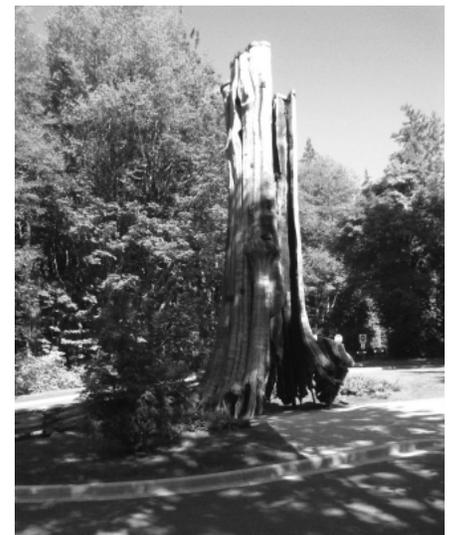
The outcome of the conservation process is a clean appearance that very much resembles the appearance of the Hollow Tree from decades earlier (Fig. 12).

Fig. 12. The Hollow Tree after conservation and landscaping, August 2011. Photograph by Harold Kalman.
