Fire and Reconstruction at Lobato Bridge in New Mexico

The oldest bridge in New Mexico was devastated by fire, leaving an operating railroad with difficult choices for balancing its reconstruction with historic preservation.

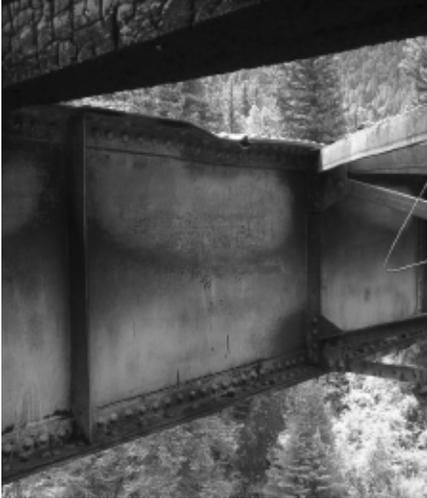
Nearly all of the timber ties were consumed in the fire, which created great heat at the top of the structure. The rails buckled. The upper flanges of the girders became distorted, buckled, and cracked in numerous places. The upper parts of the girders were raised to higher temperatures than their lower parts, evidenced by discoloration of the paint on the heated surfaces. It is believed that the lower portions of the girders, which were not distressed, and the supporting bents below, sustained no permanent damage. However, the upper portions of the plate girders, the X-bracing, and the top-flange lateral bracing all sustained significant distress (Figs. 3 and 4).

Fig. 3. Fire damage at a girder. Distortion at the upper portions of the girder flange can be seen. Paint has been burned off the upper flange and has been discolored at the upper part of the web. Photograph by Roger Hogan for CTSRR.

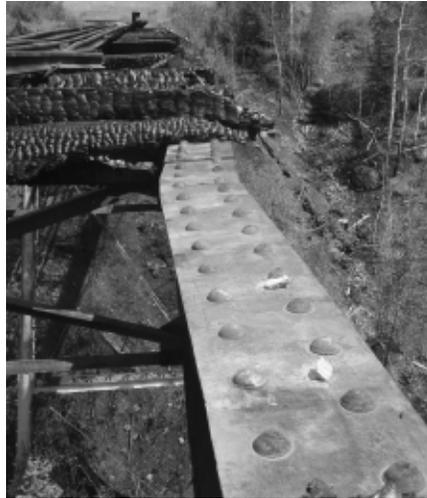
Fig. 4. Fire damage. The riveted plate girder is distorted, ties are burned, and track displaced. Photograph by Roger Hogan for CTSRR.

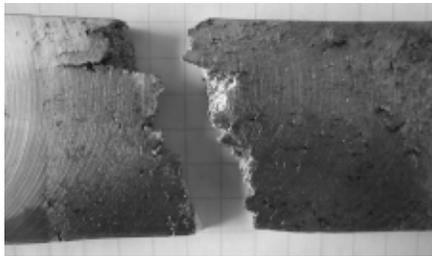
Fig. 5. Specimen, lacing bar after testing in tension failure. Photograph by the author.

Similarly, from physical testing at the University of Colorado Denver, a fibrous appearance is readily apparent along the fracture surfaces (Fig. 5). The dark spots are slag inclusions. Both the fibrous appearance on fracture surfaces and slag inclusions are characteristic features of historic wrought iron. The conclusion from the chemical tests, physical tests, and visible appearance of post-test fracture surfaces is that the material at Lobato Bridge is wrought iron.
