The Modern Plaza: Making More from Less

KENNETH M. ITLE AND HARRY J. HUNDERMAN

The Modern plaza must be durable, waterproof, structurally sound, and aesthetically pleasing. Understanding how plazas perform is essential to their successful repair.

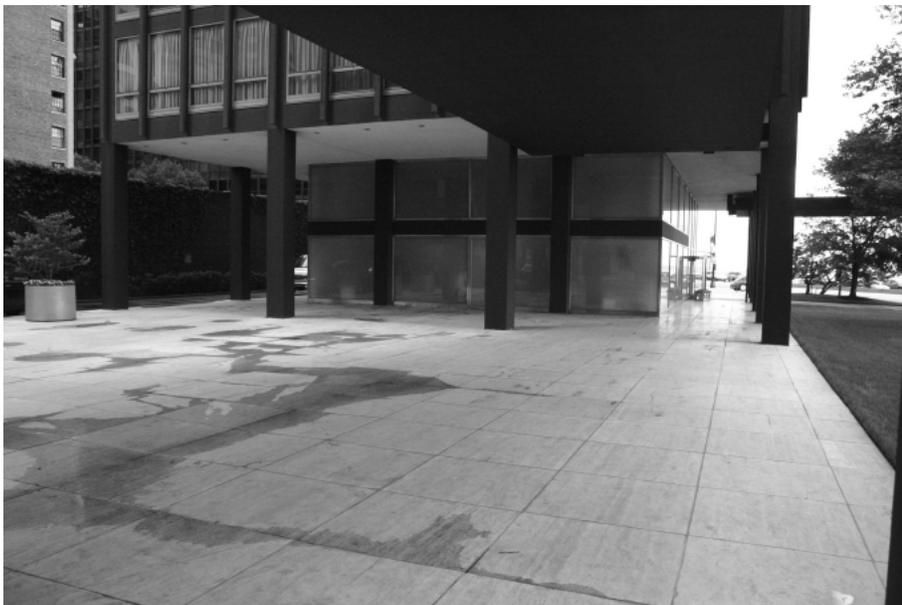
Fig. 1. 860–880 North Lake Shore Drive, Chicago, Illinois, constructed 1950–1952, photograph June 5, 2007. The exterior plaza extends around the twin apartment towers. All images by WJE unless otherwise noted.

860–880 North Lake Shore Drive, Chicago, Illinois. These apartments were designed in the late 1940s by Ludwig Mies van der Rohe and constructed

from 1950 to 1952 (Fig. 1). The innovative design features two rectangular towers oriented perpendicular to each other, with identical exteriors of steel cladding and aluminum-framed windows, united by a travertine-paved plaza that conceals an underground two-level parking garage. For Mies, the plaza served as a plinth from which the towers would rise. The desire to present the plaza as a freestanding base even led him to provide a small offset between the level of the travertine paving and the adjacent concrete sidewalks. Travertine paving was also used on the interiors of the lobbies, creating a sense of seamless space from interior to exterior. The building is a City of Chicago Landmark. For this project, Wiss, Janney, Elstner Associates, Inc., served as a subconsultant to Krueck + Sexton Architects of Chicago.

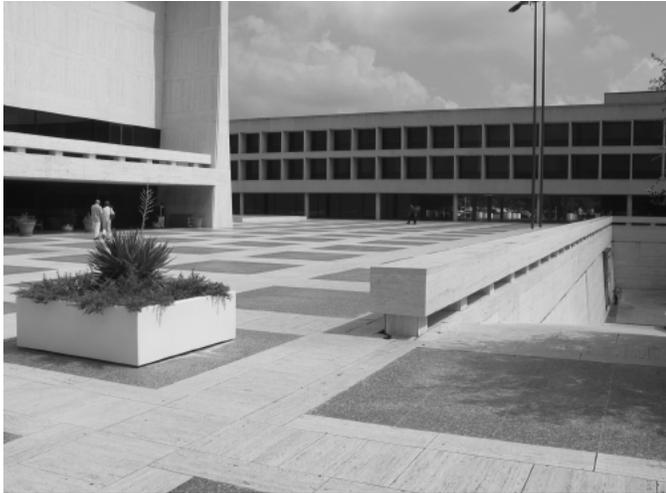
Fig. 2. Lyndon B. Johnson Presidential Library and Museum, Austin, Texas, completed in 1971, photograph Oct. 6, 2004. The library and museum tower is at left. Monumental exterior stairs descend to the lower level, where an exterior entrance leads to the classroom and lecture-hall spaces.

This complex on the campus of the University of Texas at Austin was designed in the mid-1960s by Gordon Bunshaft of Skidmore, Owings & Merrill (Fig. 2). The building complex as completed in 1971 included an eight-story museum and library tower and a three-story academic office wing, linked by a plaza paved with travertine and terrazzo. Beneath the plaza, the plinth portion of the building included lecture halls, seminar rooms, archival storage for the museum, and mechanical and unfinished spaces. Although not a designated landmark, the LBJ Library is considered eligible for listing in the National Register of Historic Places, and the project was therefore reviewed by the Texas Historical Commission. For this project, Wiss, Janney, Elstner Associates, Inc., served as a subconsultant to Overland Partners of San Antonio, Texas.
