APT LATIN AMERICA CHAPTER

- Pigeon Island National Landmark, Gros- Islet, Saint Lucia

Fort Rodney Restoration -Traditional methods for adaptability

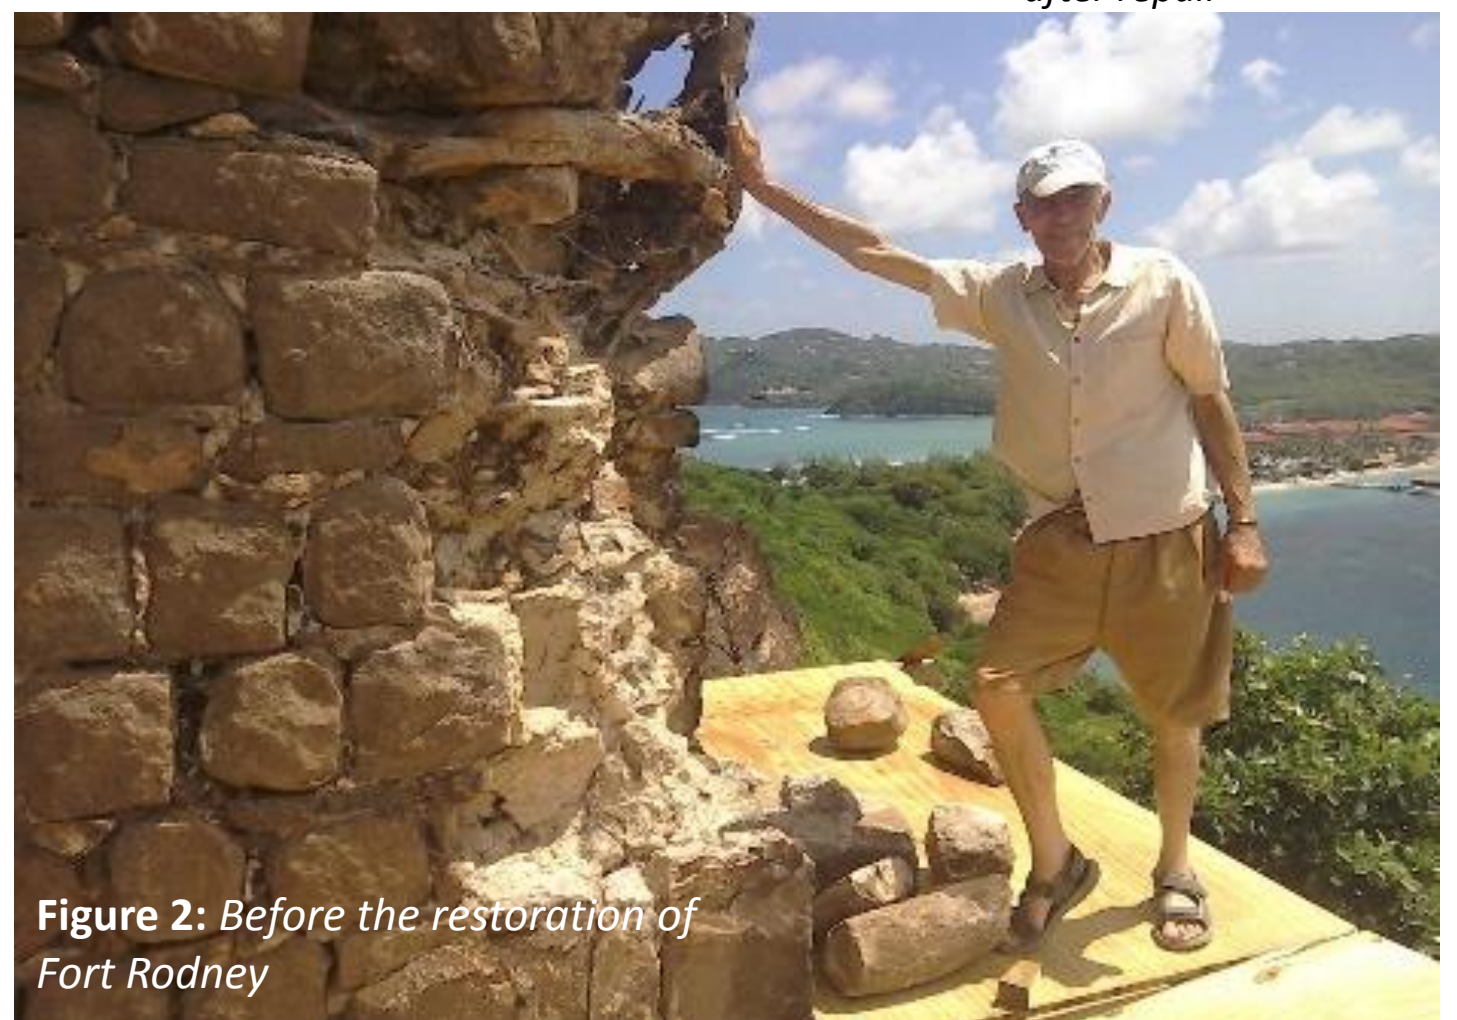
In 2017, the western corner of Fort Rodney, an 18th century fortification which played a pivotal role in the war between the British and the French for possession of the island, collapsed after the passing of tropical storm Maria. The collapse was exacerbated by a tree lodged in the south western corner of the Fort.

Figure 2: Before the restoration of Fort Rodney

Although the root was dead it took a considerable amount of skill and strategy to remove it from the corner of Fort Rodney. Mr. Martin systemically sleuthed the hillside for fallen rocks from the side of the existing structure to restore the Fort. After the collapse the rocks rolled and scattered down the hillside. Mr. Martin followed the traditional method of construction by inserting shims and binding them with lime mortar to restore the fort to its original standing.

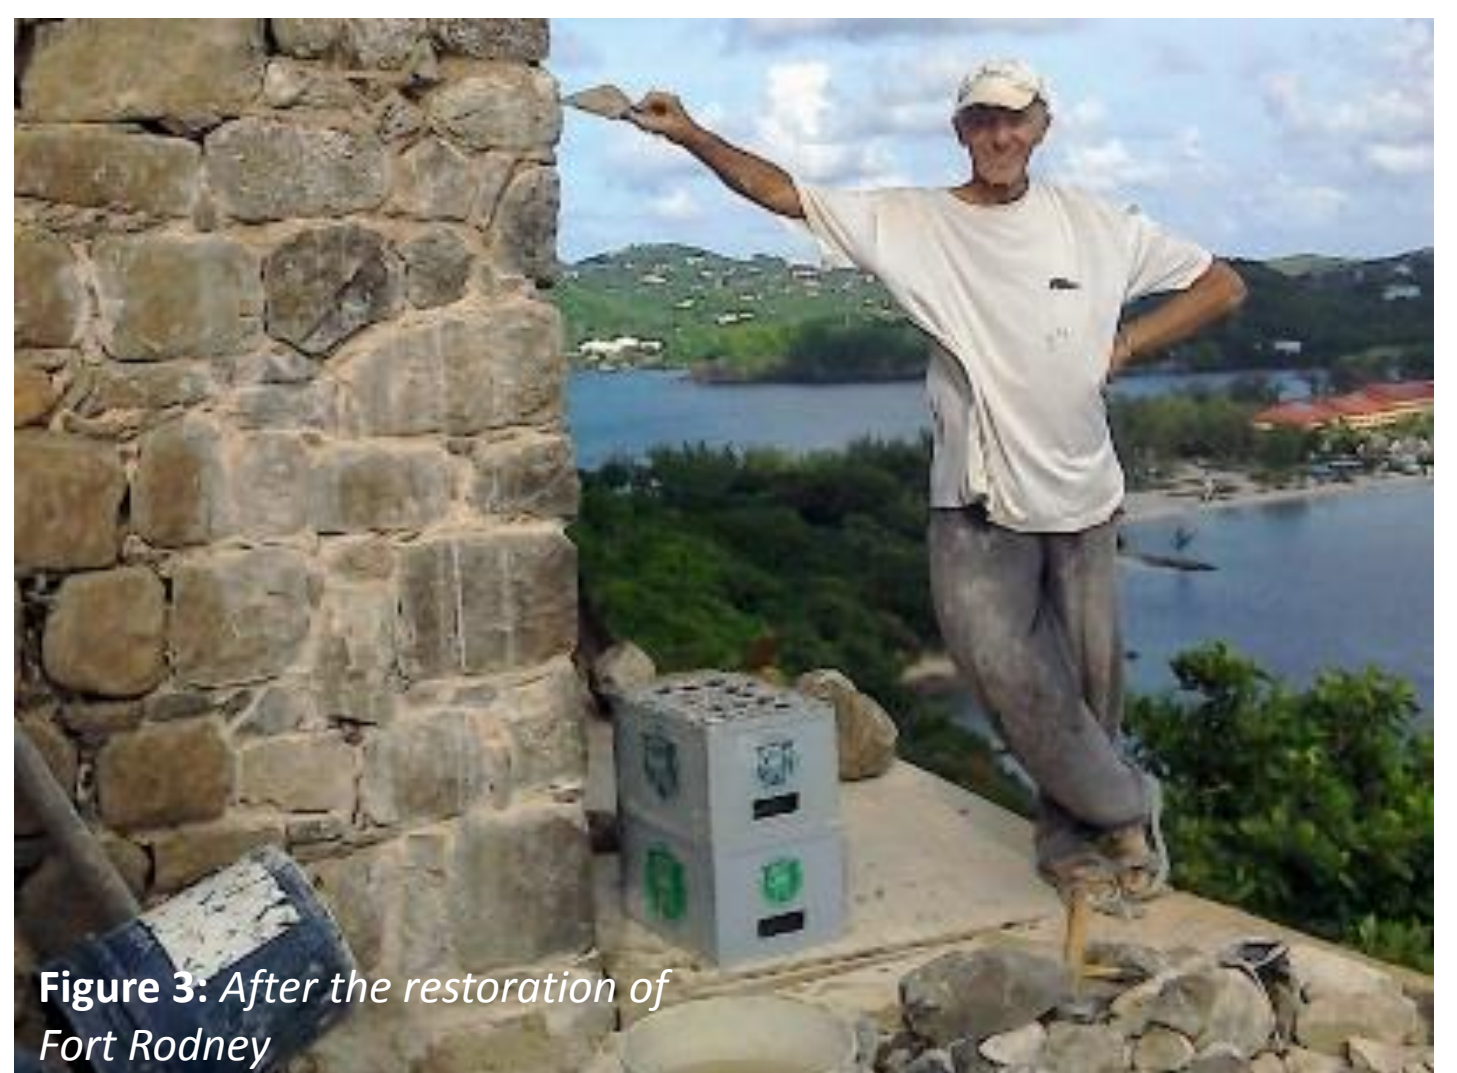
Figure 3: After the restoration of Fort Rodney

The Trust is encouraged by the successful restoration of Fort Rodney and is working towards the preservation of our built heritage. We continue to monitor the restored south western corner of the Fort for the effects of climate change.
