Fig. 1. Nyamata Genocide Memorial, Rwanda, west-facing facade and south elevation, 2016. All photographs by author unless otherwise noted.

Nyamata Genocide Memorial

Nyamata Training and Practice Project

Conservation Issues and Responses

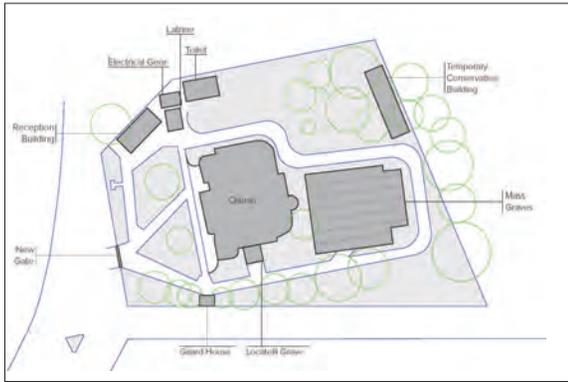
Fig. 2. Nyamata Church, site plan, 2018. Image courtesy of PennPraxis.

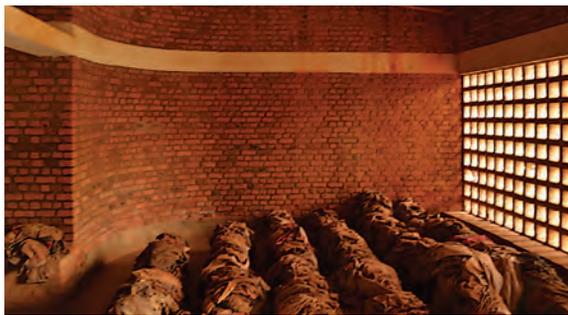
Fig. 4. Nyamata Genocide Memorial, southwest corner of the sanctuary, 2018, showing piles of textiles atop pews, claustra screen to the right, metal roof, and concrete reinforcing band.

- Assessing the condition of the sanctuary continues (especially the brick masonry, reinforced concrete, claustras, and roof assemblies), including diagnosis of deterioration mechanisms, identification of a few priority repairs (for example, a missing wall cap on the north wall), and ongoing environmental monitoring and data analysis. This also includes several interior architectural elements (altar table, tabernacle, baptismal font, day chapel altarpiece—all original to the sanctuary, character-defining, and bearing damage from April 1994).
- Reducing the flow of laterite road dust into the building is an abiding issue; it cannot be excluded without significantly altering the architectural fabric and passive ventilation of the sanctuary. Textile protection can be achieved partially by the cycling of textiles on display, periodic

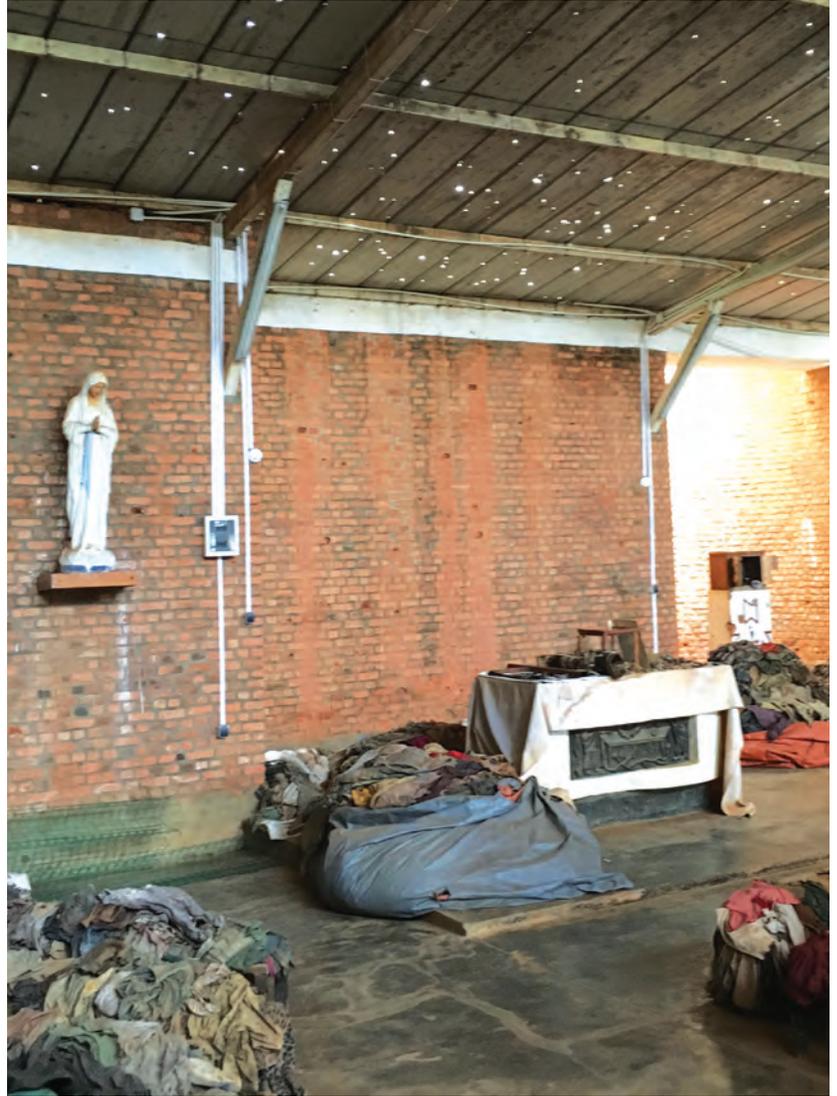
Fig. 5. Nyamata Genocide Memorial, sanctuary interior, 2019. The altar is at right; piles of textiles lie on pews in the left and right foreground; a tabernacle and baptismal font are visible at the back right. The ceiling retains bullet and shrapnel holes, now covered with clear fiberglass. Recently installed electrical conduits are visible next to the statue of the Virgin Mary at center.

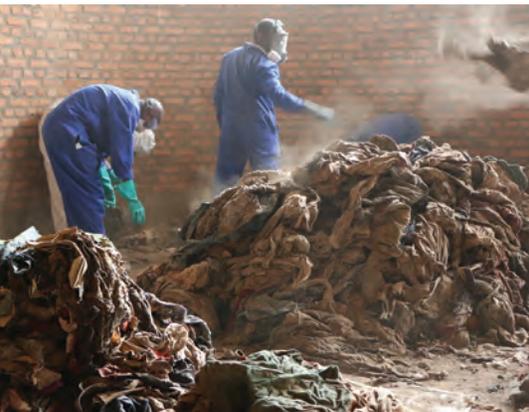
Fig. 6. Nyamata Genocide Memorial, CNLG team members sorting and cleaning the textile collection being removed from the day chapel floor, 2017. Photograph by Megan Jeffs-Rossouw.

When the team first visited Nyamata, the building and site were in good condition. However, the collections presented urgent problems: the enormous textile collection was in poor condition and deteriorating quickly (Fig. 6). Beginning in the 1990s, the Nyamata sanctuary had displayed numerous piles of ordinary clothing—the possessions of the victims—piled atop the pews in the open sanctuary (Fig. 7). This mode of display lends an immediate and vivid sense of the intimacy and scale of the killing and the absence of those killed. The team later described this quality as “experiential authenticity”—the capacity of a place to convey meaning through design, setting, and experience, not just through exclusive contact with artifacts and spaces bearing direct witness to the historic events. The collection and display of textiles in the church sanctuary is Nyamata’s most significant, character-defining element, bearing profound witness to missing bodies and lives.

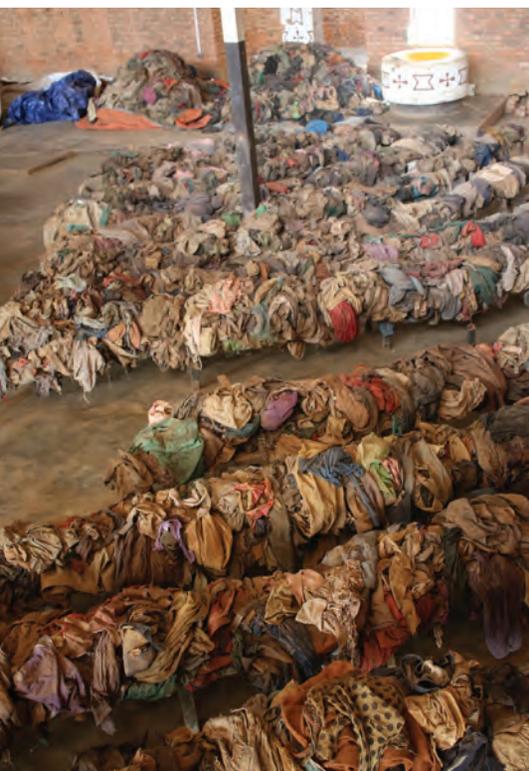
Fig. 7. Nyamata Church, sanctuary interior, 2019. Pews covered in textile piles heavily soiled with laterite dust.

Overarching the concern about the building and textile collection was the team's focus on the most urgent drivers of deterioration, namely dust infiltration, freely blowing into the building from the surrounding roads through the claustras and gates; humidity control, a fact of life given the equatorial climate and a passively conditioned building; and the presence of many pests (birds, insects, lizards, and more) actively contributing to the deterioration of textiles and architectural surfaces. In addition to these factors, the team put a priority on marshaling resources to begin textile conservation on-site as quickly as possible, requiring personnel from CNLG, materials and equipment, and space, for which the team designed and commissioned a temporary building on-site.

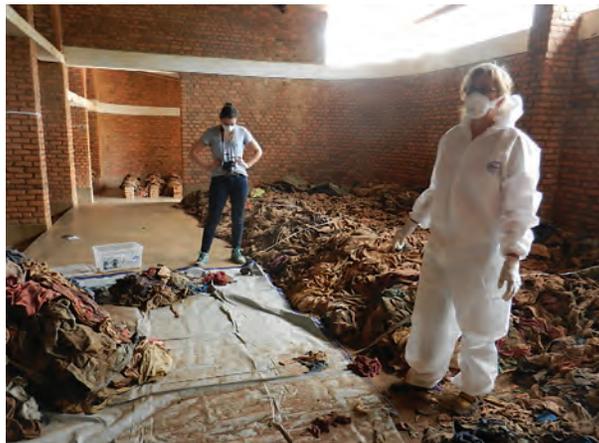
Fig. 8. Nyamata Church, day chapel at the beginning of textile sorting, cleaning, conservation, and redisplay, 2017. Photograph by Megan Jeffs-Rossouw.

- The textile collection has been the most demanding aspect of the work. Immediate measures were proposed to reduce the humidity, pests, and dust load affecting the textile collections. Meanwhile, existing piles were excavated and documented to assess conditions. The collection had to be triaged by separating it

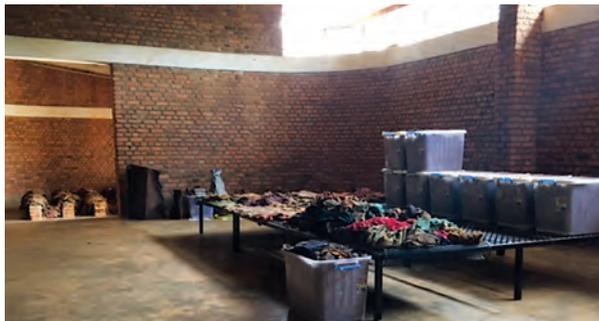
Fig. 9. Nyamata Church, day chapel at the conclusion of textile sorting, cleaning, conservation, and redisplay, 2017. Photograph by Megan Jeffs-Rossouw.

into types based on condition: those degraded beyond recognition versus those still recognizable as clothes no matter how soiled. The outcome of the textile conservation aimed at redisplaying them in more or less identical fashion (adding platforms and repairing pews). The strategy consists of sorting and partial cleaning (mechanically, without water or solvents), reducing humidity and pest vectors, cycling the collections on display, and designing new passive storage on-site (Fig. 9).¹⁷
