Testing to Determine Allowable Vibration Limits at a Natural-History Museum in the Netherlands

Object testing is critical for the establishment of vibration limits and mitigation methods for a “building-bound” natural-history collection.

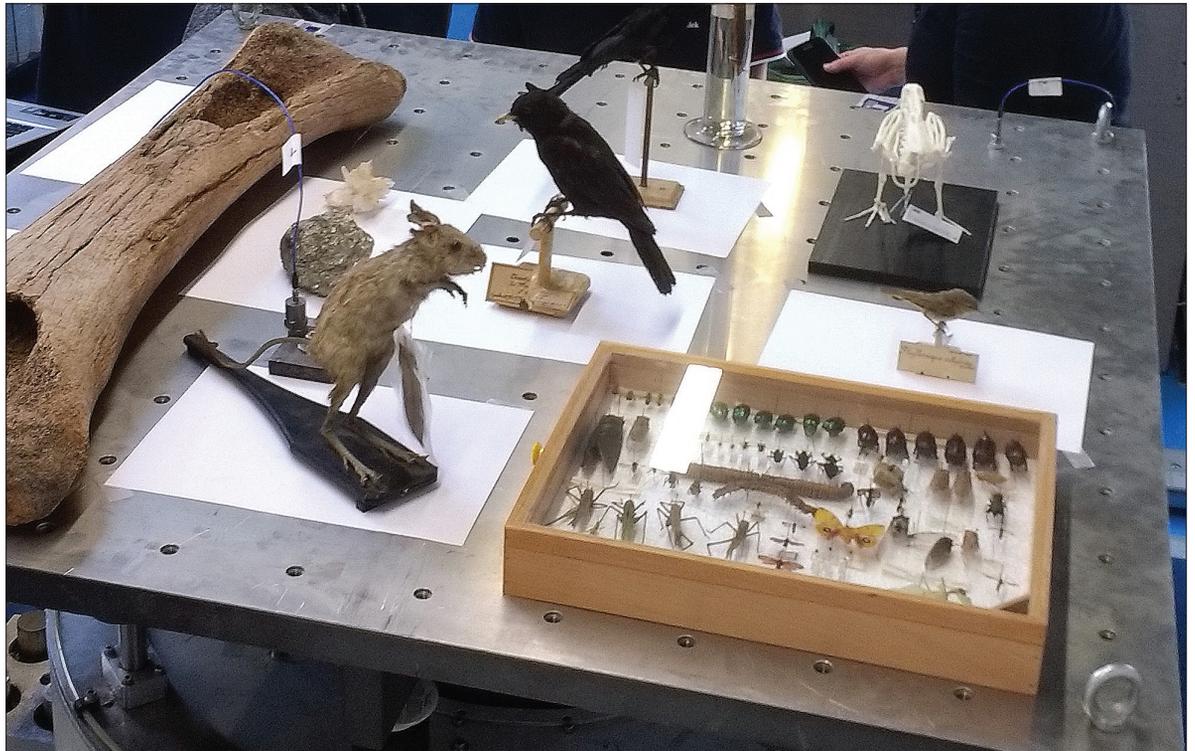
Fig. 1. Typical natural-history objects mounted on a commercial vibration-testing table. All photographs by W. (Bill) Wei, unless otherwise noted.

Vibration-testing objectives. Vibration testing was conducted on typical objects provided by Naturalis. They included mounted birds and rodents, bird skeletons, mounted insects, bottled biological samples, two crystalline mineral samples, and a large fossilized tree branch with a powdery surface (see Figs. 1 and 3). Small, empty, plastic specimen boxes commonly used for storage were also tested, stacked two to three high (Fig. 3). The objective of the testing was to provide an indication of the input levels caused by the construction work that would not result in wandering or damage to the objects in the vicinity. This information was used to determine vibration limits for the construction work.

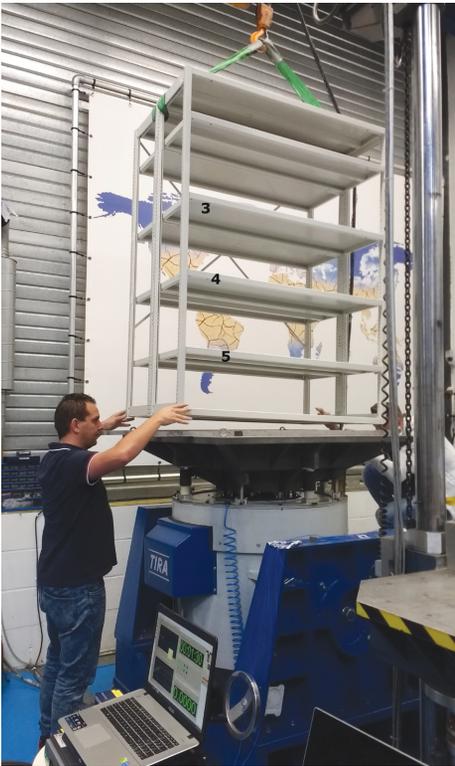
Fig. 4. Metal shelving from Naturalis being placed on the vibration table. The shelving is not fixed to the vibration table, but side beams prevent it from wandering.

Vibration-testing setup. Vibration testing was conducted on a commercial vibration-testing table operated by Sebert Trillingstechniek, B.V. The situation in the storage facility was simulated by placing typical shelving from Naturalis on the vibration table (Fig. 4). The shelves were not fixed to the vibration table, simulating the many freestanding shelves in the facility. However, metal side beams were placed against the feet to prevent the shelves themselves from wandering during testing.

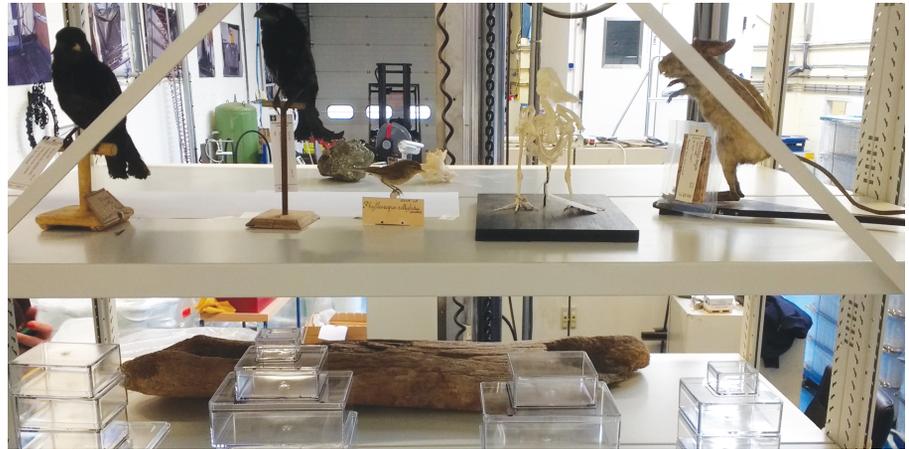
Fig. 3. Objects on shelves for vibration testing.

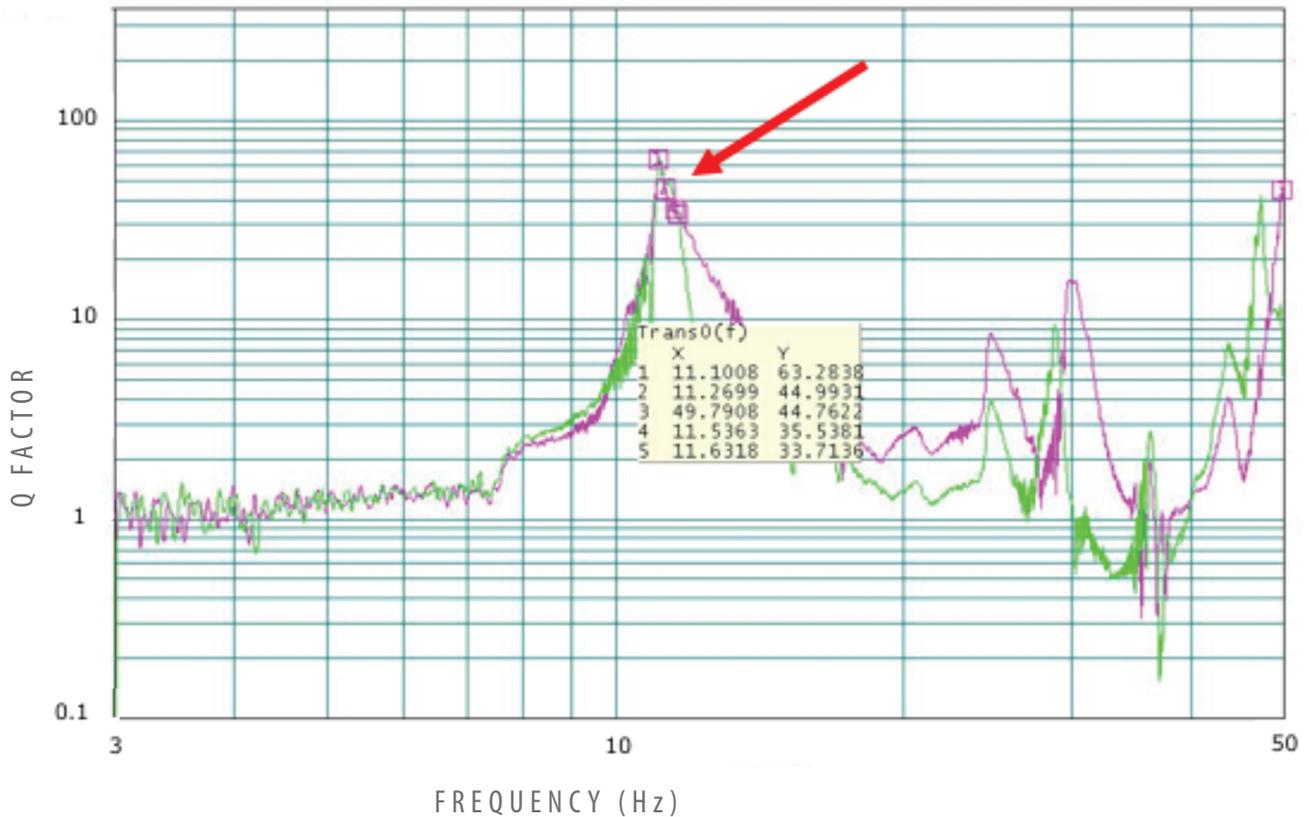
Fig. 5. Plot of Q factor versus frequency for shelves 3 and 5. The main resonance peak for both shelves is 11 Hz (red arrow).

The resonant frequency is that at which the Q factor peaks; see, for example, Figure 5. This frequency is determined not only by the material properties of a particular object but also by its size, geometry, and weight. At resonance, the object would thus be expected to experience damage sooner than at the input vibration level.

The results of the resonance testing of the shelves are shown in Table 1. A typical plot of Q factor versus frequency is shown in Figure 5 for shelves 3 and 5 without objects. The main resonant frequency for both shelves is 11 Hz, and there are secondary resonant peaks at 25, 30, and 50 Hz. The resonance behavior of all three shelves was similar, as shown in Table 1. The empty shelves showed a main resonant frequency of 11 Hz, which was up to 60 times the input level (Q factor of 60). Resonant frequencies were also observed at 25, 30, and 50 Hz, with the Q factor at 50 Hz also being fairly high (Q factor of 40). The shelves with objects on them resonated at similar frequencies but with lower Q factors. The main resonant frequency was slightly lower (8 to 9 Hz) than that for the empty shelves with Q factors up to 25.
