# The Reassembly of the Rideau Street Convent Chapel in Ottawa

Harold Kalman

Not unlike piecing together a jigsaw puzzle, a magnificent nineteenth-century religious interior was dismantled and reassembled in the National Gallery of Canada.

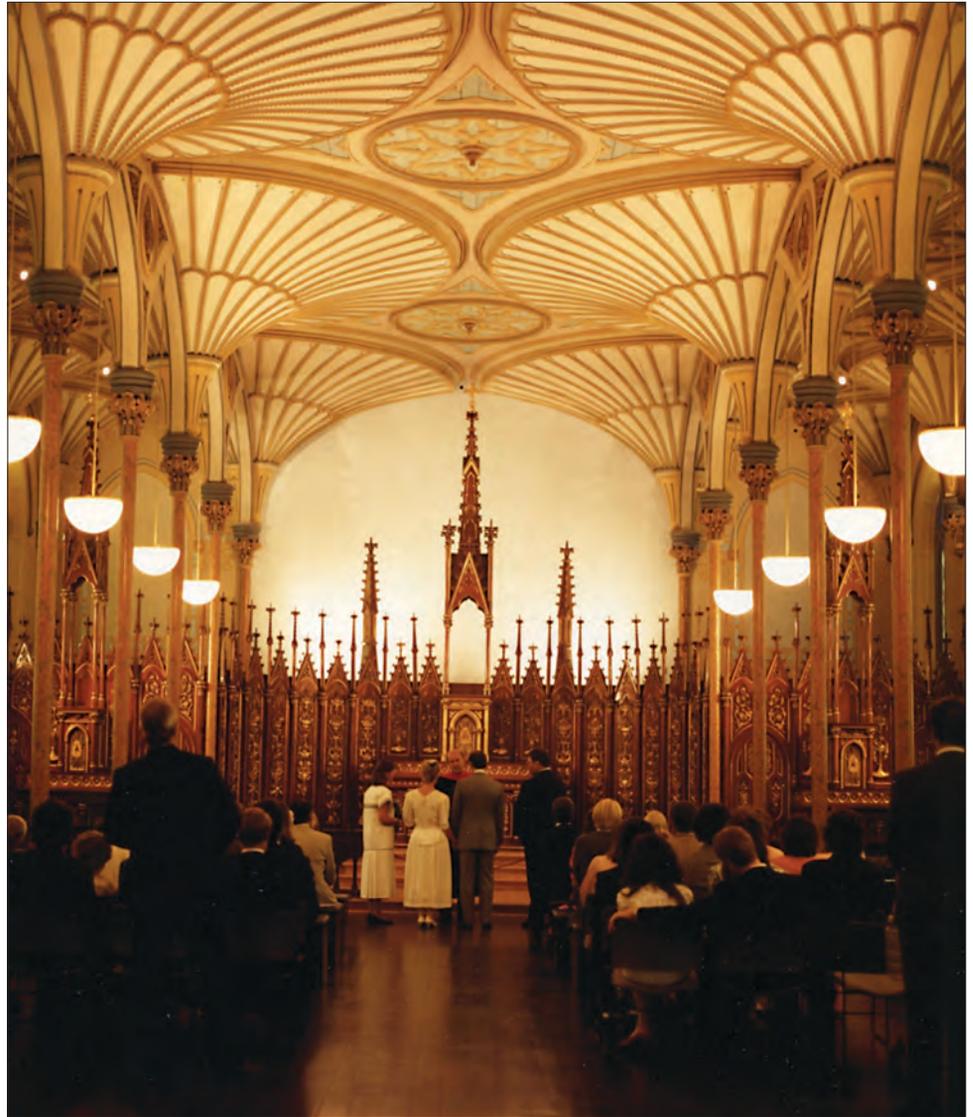
Fig. 1. The Rideau Street Convent Chapel, Ottawa, Ontario, built 1887–1888, in the National Gallery of Canada. Photograph by Michael Bedford Photography, August 1988.

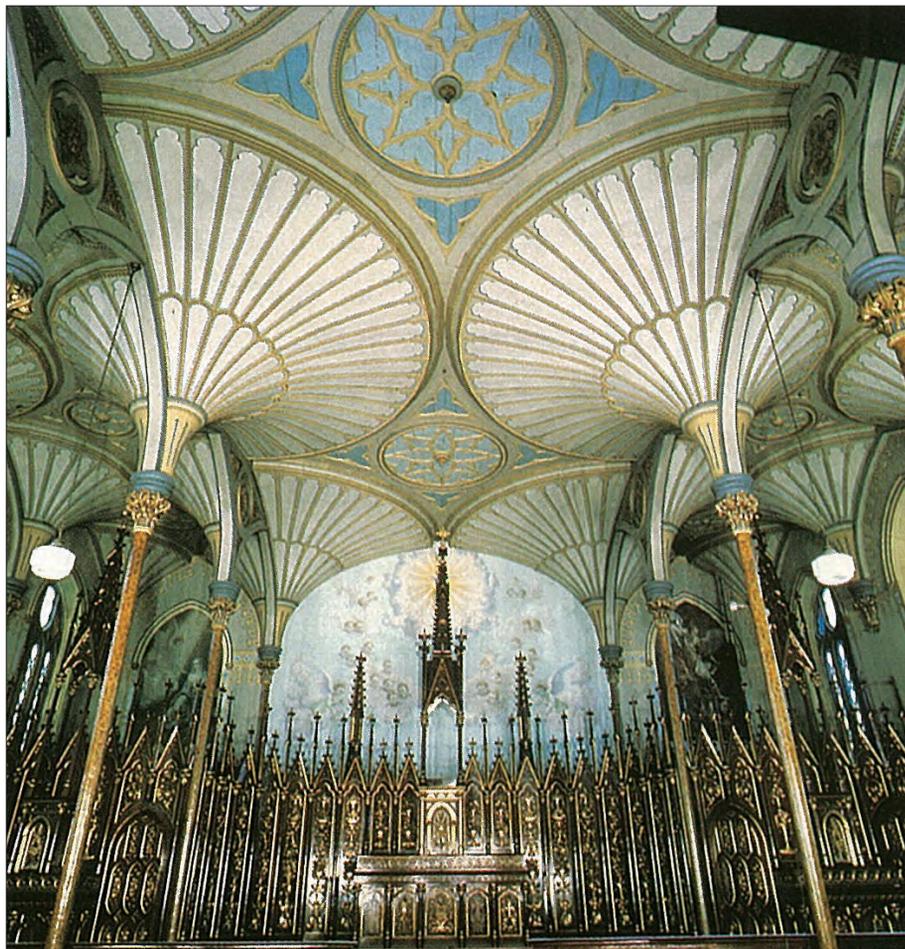
Fig. 2. Interior of the Rideau Street Convent Chapel, in situ in the convent, 1972. All images courtesy of Luc Noppen, *Une des plus belles chapelles du pays* (Ottawa: Musée des beaux-arts du Canada, 1988), unless otherwise noted.

The surviving Gothic revival altar and choir screen, resplendent with intricate tracery, were designed by Georges Bouillon (see Fig. 2). Missing portions were replicated and the original communion rail was reused. Paint was infilled as needed on the ceiling and the wall stenciling. The rag-rolling decoration on the cast-iron columns was replicated, using the original technique. The column capitals were gilded.<sup>19</sup>

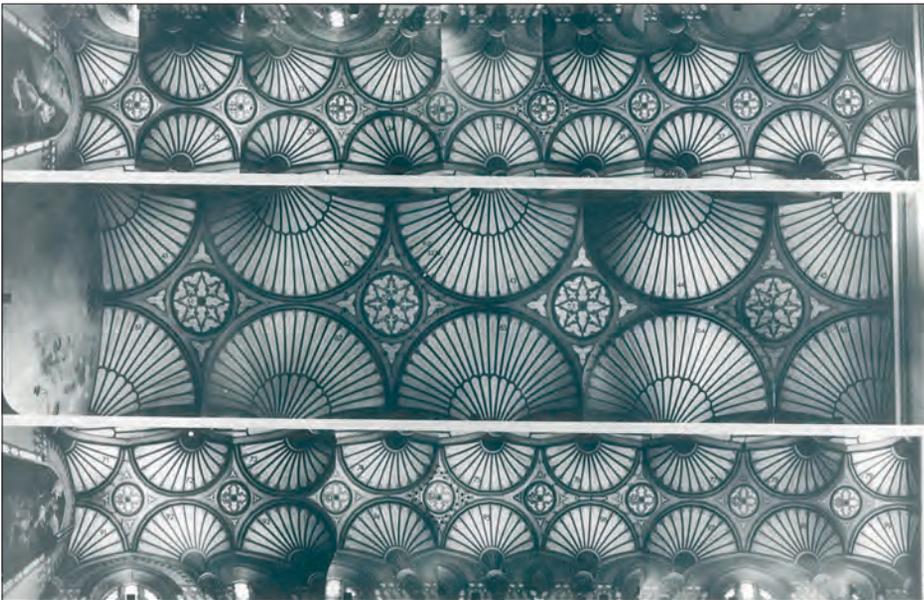
Fig. 3. Composite photogrammetric image of the fan vaulting, 1972. Courtesy of Parks Canada.

Glenview Realty’s eagerness to proceed with the redevelopment of the site made removing the chapel a hasty rescue mission. Professionals from Parks Canada and the National Research Council and students from Algonquin College of Applied Arts and Technology documented the chapel thoroughly. Their measured record drawings and photogrammetry, produced in 1972, proved indispensable in the reassembly (Fig. 3).

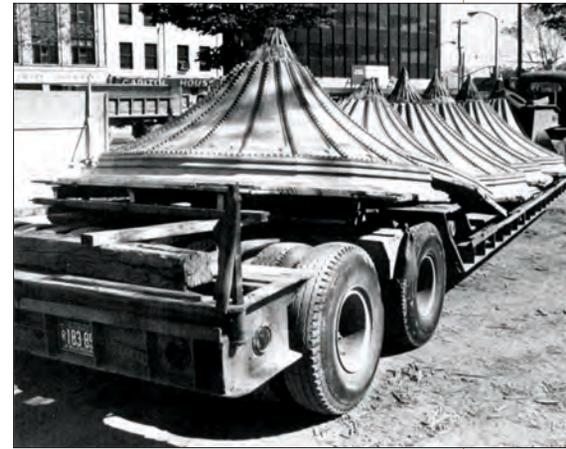
Fig. 4. The fan vaults were transported on a flatbed truck from the condemned convent to the Connelly Building, a warehouse in Ottawa South, May 1972.

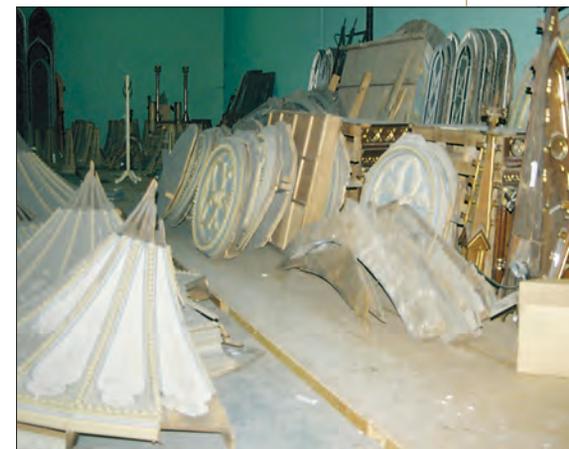
Fig. 5. The large components of the disassembled chapel were stored in the warehouse before the trial assembly. Photograph by Craig Sims, 1985.

The components of the chapel had been stored randomly in the warehouse, pieces stacked against pieces (see Fig. 5). No one knew how many there were, whether any were missing, or where any particular piece might be found. The largest components were the 18 half-fan vaults from the ceiling of the nave, each measuring 4.4 by 3.3 meters (14.44 by 10.83 feet) and requiring six persons to lift (see Fig. 4). Their original locations were determined by comparing small distinguishing features—notches, scratches, and splashes of paint—to the photogrammetric images. The cast-iron columns each took 10 persons to lift. Other pieces were more manageable: the aisle fan vaults, ceiling roundels and trefoils, arcade spandrels, window sash, cast-iron corbels, and the disassembled altar. Among the smallest were several dozen altar finials, many under 300 millimeters (about 1 foot) long. Countless bits of molding trim were strewn across the warehouse floor.

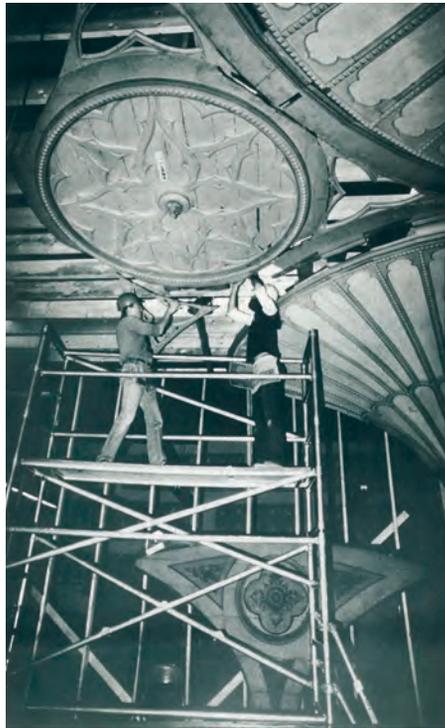
Fig. 6. Dennis Carr, carpenter, left, and Craig Sims, site manager, move a roundel into place during the trial assembly, 1986.

A framework of wooden joists, simulating part of the chapel's ceiling support system, was constructed in the warehouse. A moveable scaffold provided access (Fig. 6). Three assembly methods were tested to determine the best way to lift the fan vaults and fasten them to the joists. The process allowed the team to understand the subtleties of the structural system and to ensure the replication of the original curvatures as closely as possible.

The first ceiling components to be installed were the large fan vaults. They were lifted with a hoist and guided into place manually (see Fig. 6). The team fixed the fan vaults to the joists, further supporting each vault on a cast-iron column. The heritage recording provided the dimensions between the plaster walls

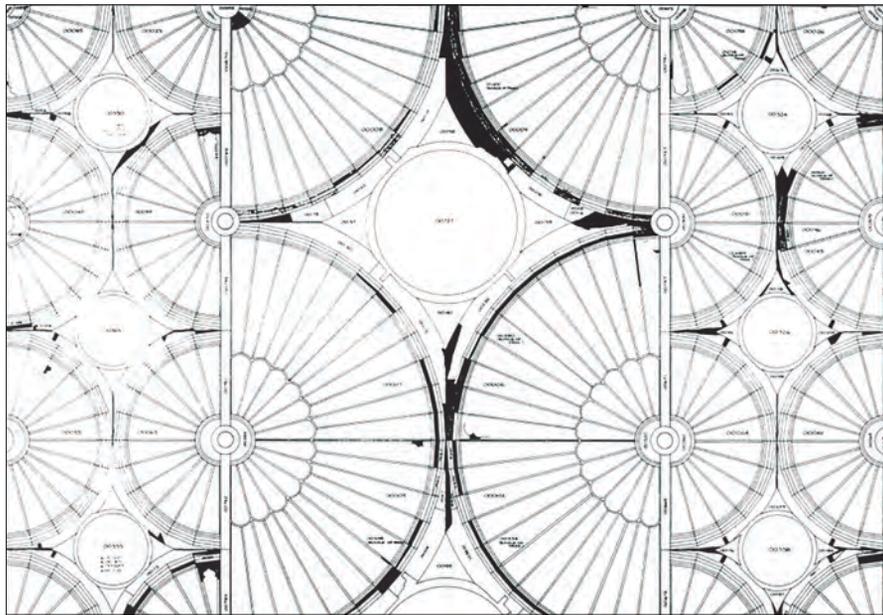
Fig. 7. A portion of the reflected ceiling plan; the dark areas indicate missing wood that required infill. Drawing by Caroline Guay, 1986.

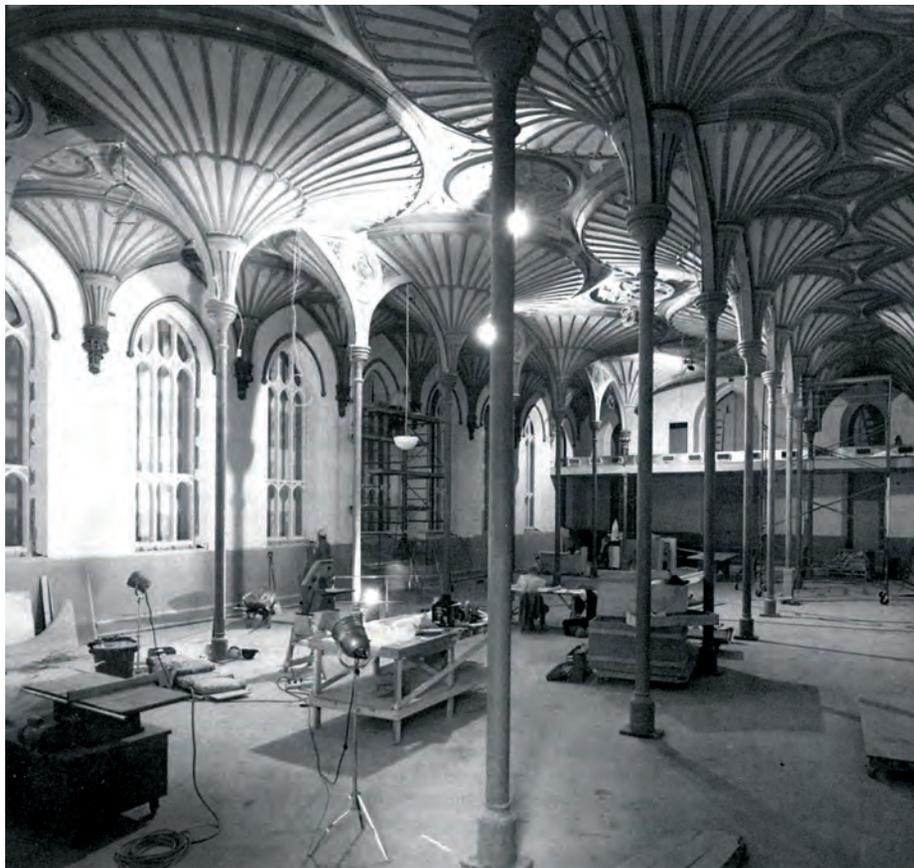
Fig. 8. A view of the chapel with the ceiling completed, December 1987. The railing of the balcony at the far end has not yet been installed.

The balcony of the chapel was reconstructed to resemble the original. The railing had been salvaged and was reused, with some of its parts replaced and repaired. Visitors have no access to the balcony, although the staircase was partially reconstructed (Fig. 8).
