The Metropolitan Floor: Modern Analysis of an Archaic Structure

DONALD FRIEDMAN

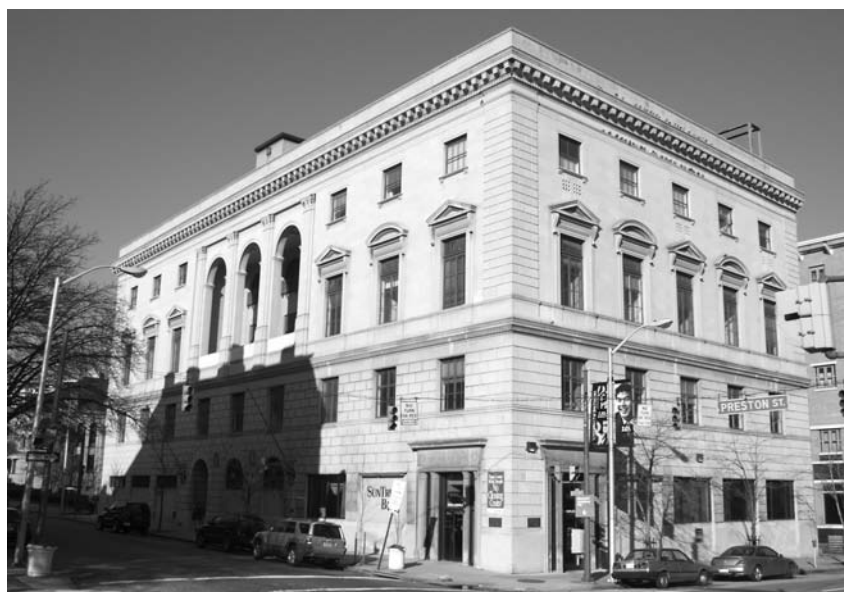
Fig. 1. Exterior of a building erected in Baltimore in 1927 as a private club. The Metropolitan Floor is still in place, and the building is currently undergoing renovation. All images by the author.

One of the floor systems approved by testing by 1899 and used sporadically from the 1900s to the 1930s was the Metropolitan Floor, patented circa 1895 (Fig. 1). It was also later sold under the name "Pyrofill." The system consists of a series of steel wires that are draped over the top of the floor beams and serve as catenary supports for the floor loads (Fig. 2). The wires, arranged in twisted pairs, are encased in a slab composed of gypsum with small wood chips embedded

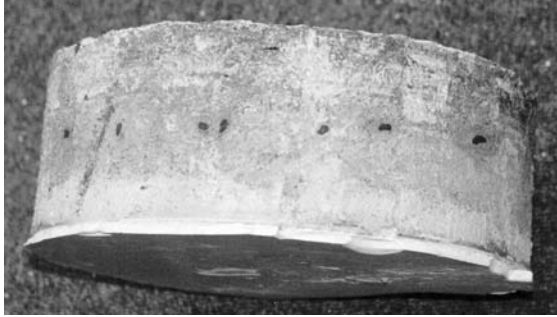
Fig. 4.
Core through floor showing the thin layer of finish plaster on bottom and the cut ends of wires.

in it (Figs. 3 and 4). The slab serves the structural function of providing a flat and fire-resistant surface. It spans the 1 to 3 inches between the wires but does not participate as a major stressed element. The wires are anchored at all intersecting slab edges by simple twisted connections over light steel supports (angles or straps) bolted to the structural frame (Fig. 5).

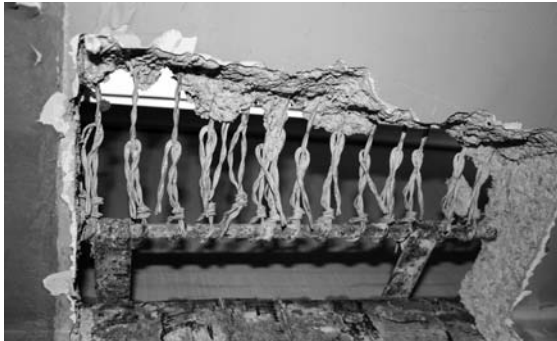
Fig. 5.
Probe at the inside face of a spandrel beam showing wrapped attachment of the wires to secondary steel.
