Data Interpretation and Early Corrosion Test Program for Historic Concrete Buildings

GINA CREVELLO

Practice Points presents essential information on technical topics related to preservation practice for both new and experienced professionals.

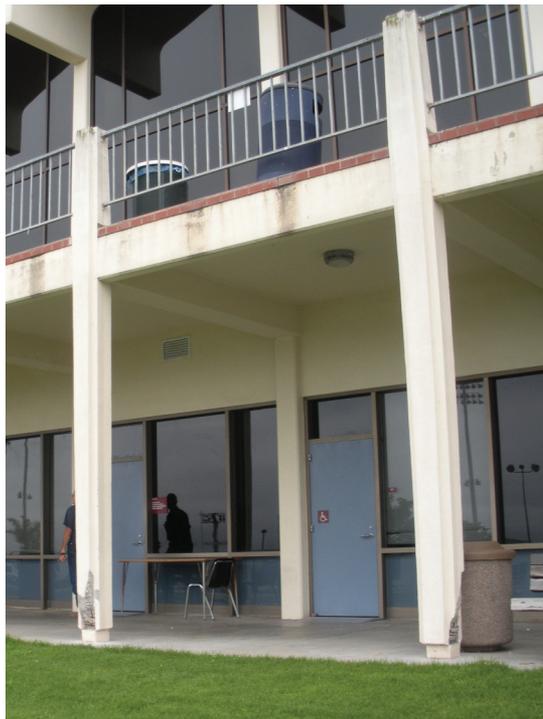
Fig. 1.

College center building, Santa Barbara, California, c. 1960, west elevation, 2010. Typical conditions encountered when assessing historic concrete building, including corrosion at the bases of the columns. All images by the author, unless otherwise noted.

diffusion, metal loss, and critical section loss can be used in durability and service-life models to predict when the structure may see failures ranging from microcracking to obsolescence. This methodology approaches deterioration in a holistic manner, addressing all factors that affect concrete corrosion and durability. This approach can be very insightful when assessing historic concrete buildings where the original material and the structure itself are a cohesive unit (Figs. 1 through 3).

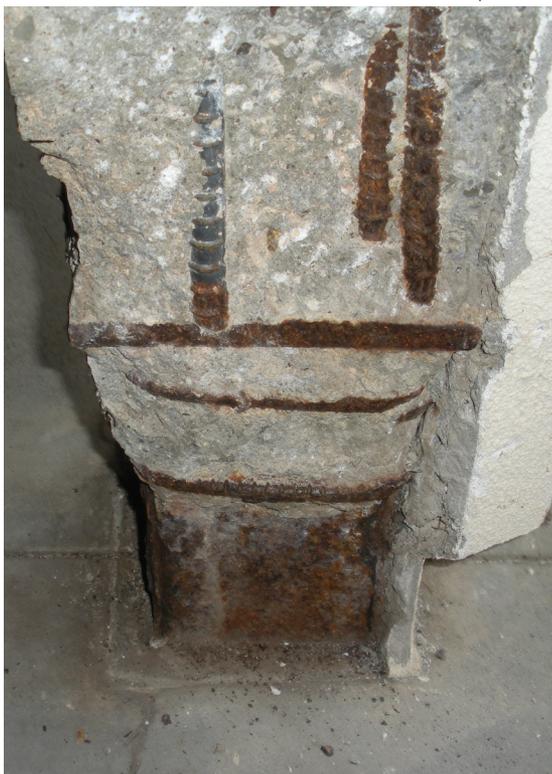
Fig. 2.
College center building,
west elevation. Detail of
corrosion-related
deterioration at
column bases.

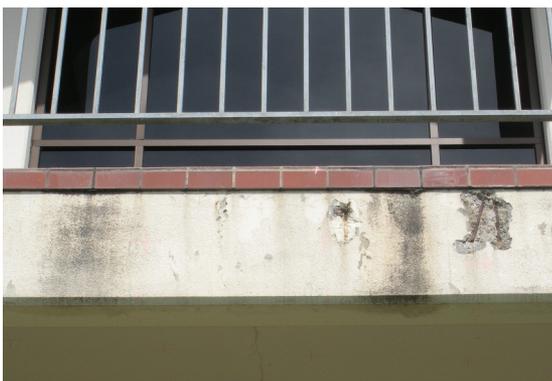
Fig. 3.
College center building,
west elevation, detail of
edge of balcony slab. The
structure has relatively low
concrete cover, and the
subsequent corrosion of
the steel has caused
spalling and has exposed
reinforcing steel.

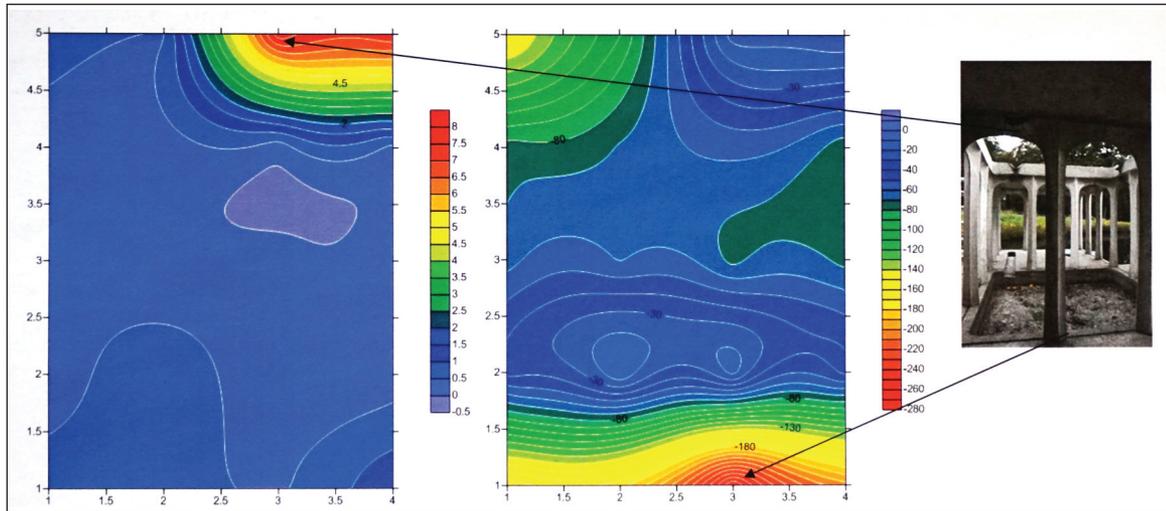
Fig. 4. Pre-cast concrete structure, c. 1960. The electrochemical test program is represented with contour maps illustrating corrosion rate (left) and corrosion potential (right). The most negative potentials indicating highest risk do not correlate with the highest corrosion-rate activity.

By comparing the potentials and corrosion rates, a good picture is often generated as to where corrosion is occurring. Most often, one finds that, although the readings may be low according to standard, the most negative potentials may not always coincide with the highest corrosion rates of the particular subject (Figs. 4 through 9). By combining the two methods of electrochemical evaluation, a clear picture is defined by the introduction of the corrosion-rate measurements with the potentials. One item to keep in mind, however, is that the corrosion rate does not distinguish between general corrosion or pitting corrosion. It is often found that the highest corrosion rates do not always occur near the highest potentials. Table 5 illustrates that all the data collected from Bay 13 in the testing program had potentials more positive than (>)-150mV, or within the low risk category for corrosion probability, yet corrosion rates were as high as 5.59 microns per year. Corrosion rates of 4 microns per year should be of concern when assessing an historic concrete building. Also note, that the average cover of the balcony slab was just over 1 inch, which is not a suitable cover for a durable concrete structure.

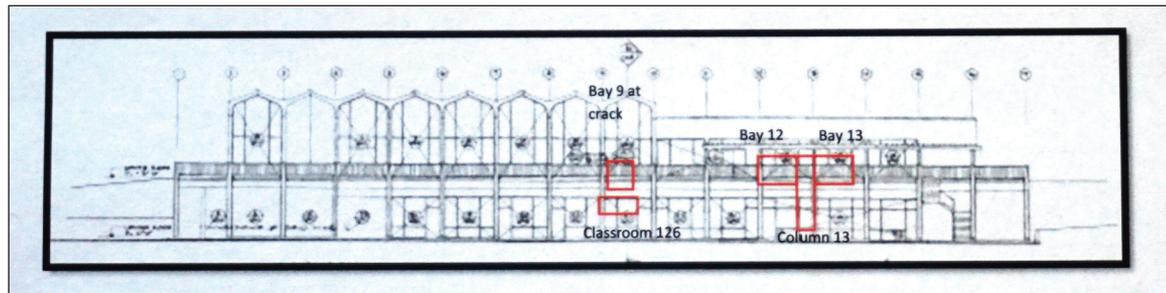
Fig. 5. College center building, west elevation, areas of electrochemical testing outlined in red.

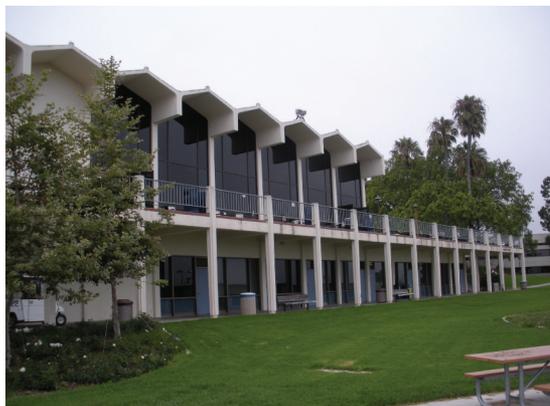
Fig. 6. College center building, west elevation, areas of testing locations for Figures 7-9.

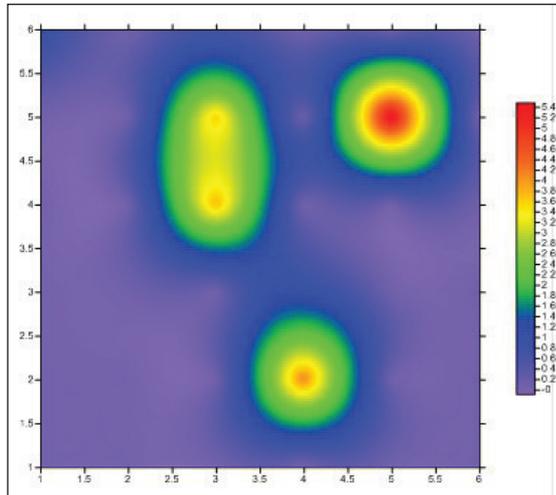
Fig. 7.
College center building,
corrosion-rate contour
map for Bay 13 as
identified in Figure 5.

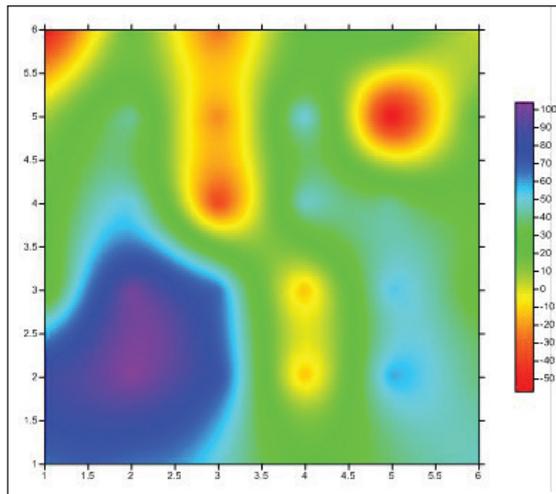
Fig. 8.
College center building,
half-cell-potential contour
map for Bay 13.

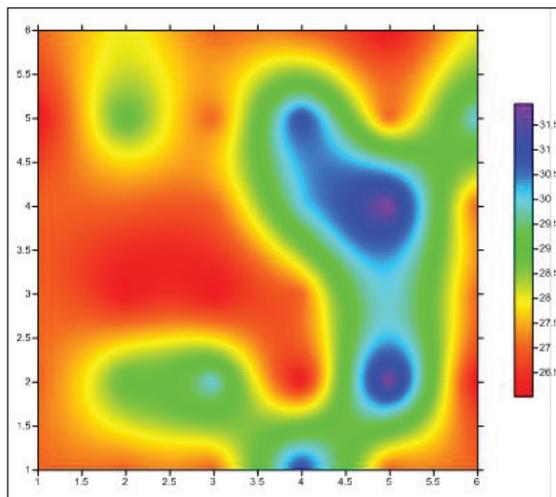
Fig. 9.
College center building,
contour map of concrete
cover for Bay 13.
