Assessment of Historic Concrete Structures

ANN HARRER AND PAUL GAUDETTE

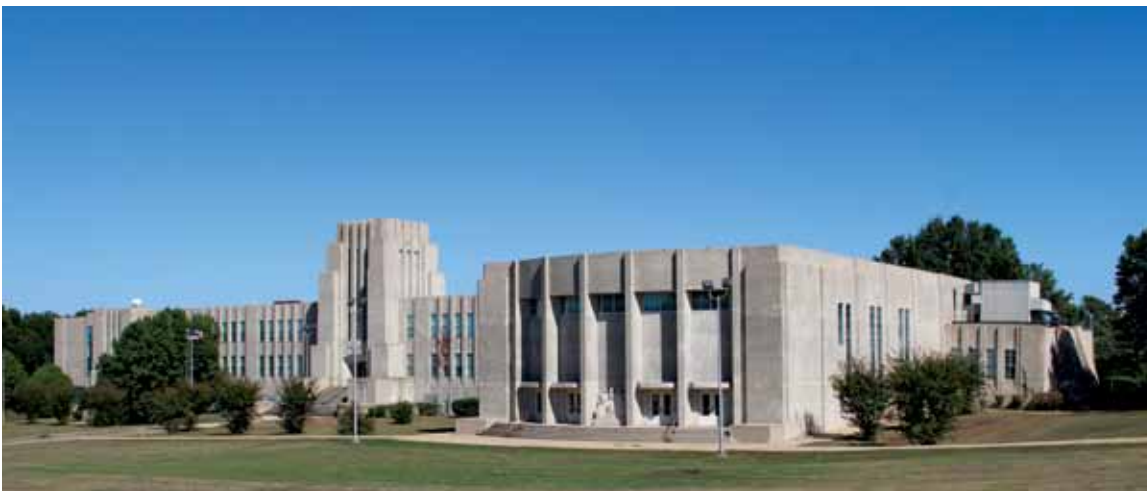
Fig. 1.
Exposed architectural-concrete facade and concrete elements at the Bailey School in Jackson, Mississippi, designed by architect A. Hays Town and built in the 1920s. Photograph 2016. All photographs by the authors unless otherwise noted.

only for structural elements but also for architectural finishes on both the exterior and interior of buildings. Widely used in modernist architecture, concrete essentially defined the brutalist architecture movement, named after the French term *béton brut*, meaning raw concrete. Architects Le Corbusier, Erno Goldfinger, and others pioneered the brutalist movement. Other modernist architects, such as Louis Kahn, Tadao Ando, and Welton Becket, continued the use of concrete in architectural elements in their designs. Figures 1 through 3 illustrate the use of exposed concrete as an architectural component.

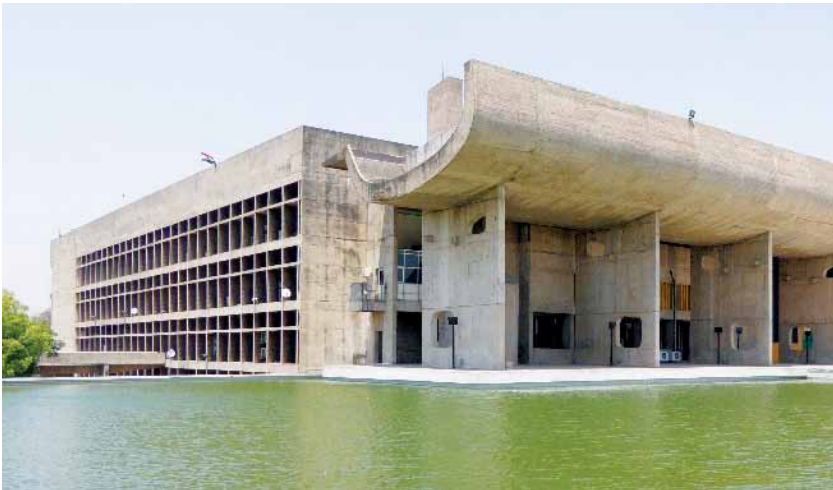
Fig. 2.
Exposed concrete used as architectural finish at the Legislative Assembly in Chandigarh, India, designed by Le Corbusier, 2016.

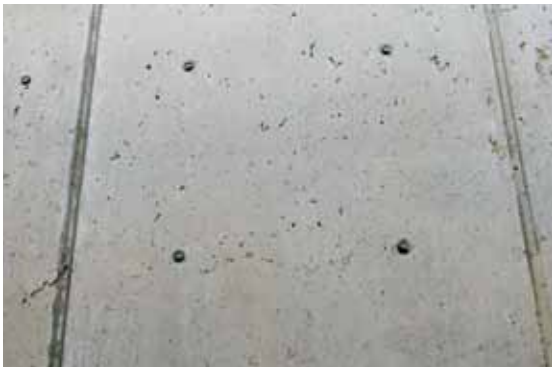
Fig. 4.
Smooth-form concrete finish.

as well as to construction methods, as these factors directly impact the overall aesthetic. By varying the amount and type of material constituents, including the aggregates and cements, the material properties and color of the concrete can be adjusted. Construction methods and finishing techniques directly impact the final surface appearance and texture. Some of the various finishing techniques used historically, as well as today, include exposing the aggregates, retaining the texture from the formwork for a rougher finish (board form), and rubbing to create a smooth finish (Figs. 4, 5, 6, and 7).

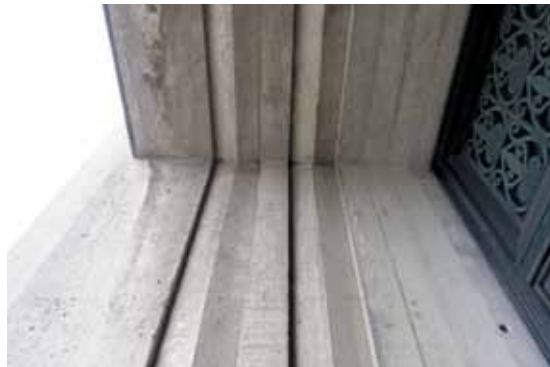
Fig. 5.
Board-formed concrete finish.

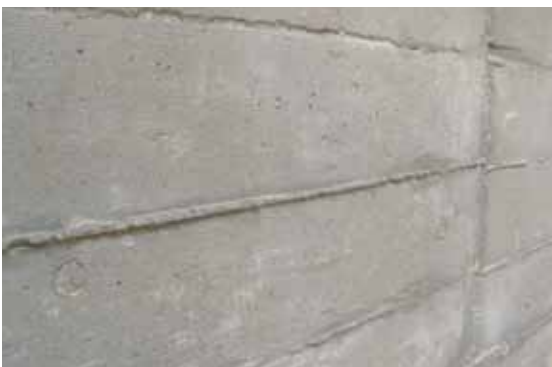
Fig. 6.
Board-formed concrete finish.

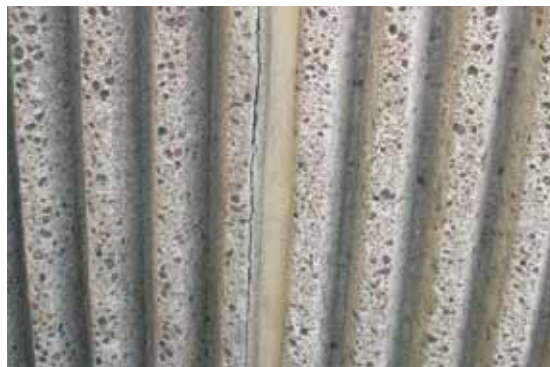
Fig. 7.
Exposed-aggregate concrete finish.

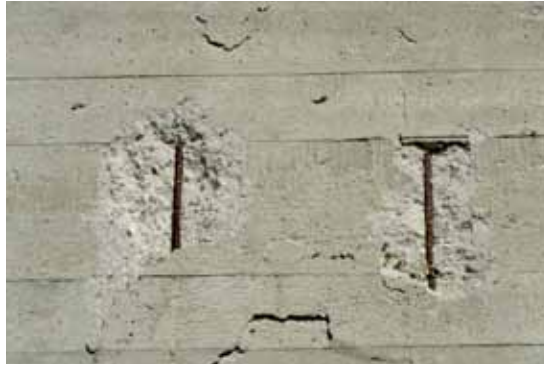
Fig. 8.
Delamination and spalling
in exposed concrete,
documented as part of the
visual condition survey.
Photograph by Adrienne
Goetz, WJE.

The condition survey starts with a visual survey and the documentation of the existing conditions of the concrete components, including the structural and architectural elements and the original concrete finish and texture. Coatings or membranes applied to the concrete and the condition of these systems should also be investigated and documented. Documentation of observed deterioration, including spalling and cracking, typically includes photographs, notes, and annotations on plans or elevations to indicate locations and sizes of observed deterioration and distress. Cracking is not an unusual condition; however, the investigation and documentation of cracking can provide information regarding why the cracking occurred. The condition survey can also yield information about original construction such as placement techniques, poor consolidation of the concrete during placement, and other issues. Spalls that expose corroded reinforcement are of particular interest, as this is a primary deterioration mechanism, and can also provide information on reinforcement (Fig. 8).

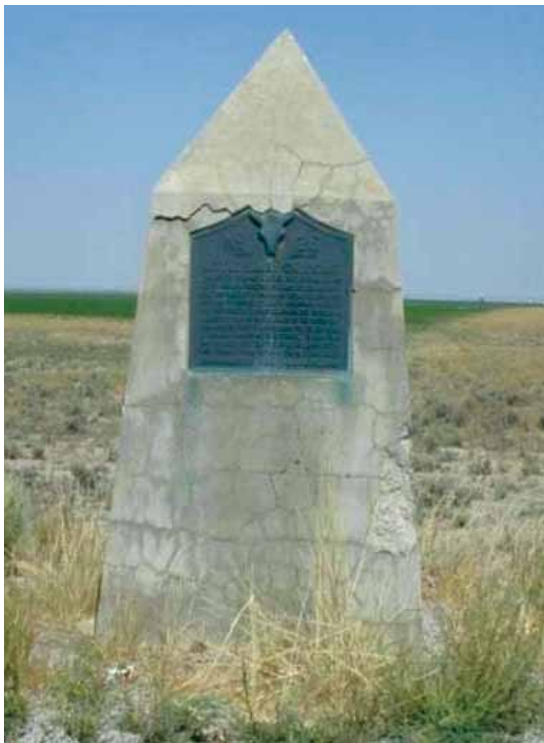
Fig. 9.
Freezing- and thawing-
related distress at a historic
exposed-concrete monument,
Wyoming, 2008.

The use and exposure of the structure should also be documented (Fig. 9). For example, as chlorides can induce corrosion of the reinforcement, it is important to note any potential external chloride sources; these sources may include salts used on adjacent sidewalks or driving surfaces in the winter to reduce snow and ice or the proximity of the structure to the ocean. The location of the building and source of materials present may yield information regarding the original construction. For example, local sand or soil with characteristics unique to the location may have been used as fine aggregates, which can impact the performance of the concrete. If deterioration appears unique to, or particularly prominent at, one portion of the structure (for example, where guardrails are attached), these conditions should be documented. Localized or unique deterioration may be indicative of inappropriate construction practices at a portion of the structure, structural concerns, incompatibility of materials, deterioration related to use of the structure, or other distress mechanisms affecting only a specific component or area of the structure.

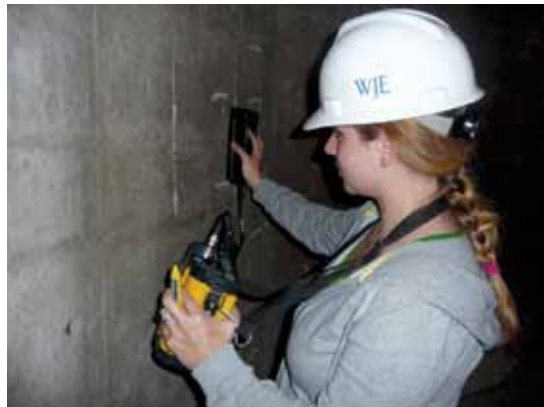
Fig. 10.
Use of nondestructive testing to determine location of reinforcement steel during an assessment of a concrete structure.

Nondestructive evaluation can provide some information regarding the location of reinforcement, properties of the concrete, and the location and extent of distress. The most common type of nondestructive testing is sound testing, which involves tapping the concrete surface with a hammer or other hard instrument or by dragging heavy chains over horizontal surfaces to identify areas of delaminated and unsound concrete; these areas will sound hollow or dull. Sounding is a simple and valuable field-testing technique and should be utilized in most concrete structure-condition surveys. Other nondestructive-testing techniques involve passing ultrasonic or radar waves through the concrete and measuring the response; changes in wave frequency or speed can indicate embedded components or distress within the element not visible at the surface. Ground-penetrating radar and cover meters are commonly used to confirm as-built conditions, such as dimensions, when only one side of the concrete element is accessible; these techniques also help identify the location of reinforcement and other embedded or encased items (Fig. 10). Exploratory openings are used to confirm results from nondestructive testing.
