# U-value Monitoring of Infill Panels of a Fifteenth-century Dwelling in Herefordshire, UK

Christopher J. Whitman  
Oriël Prizeman

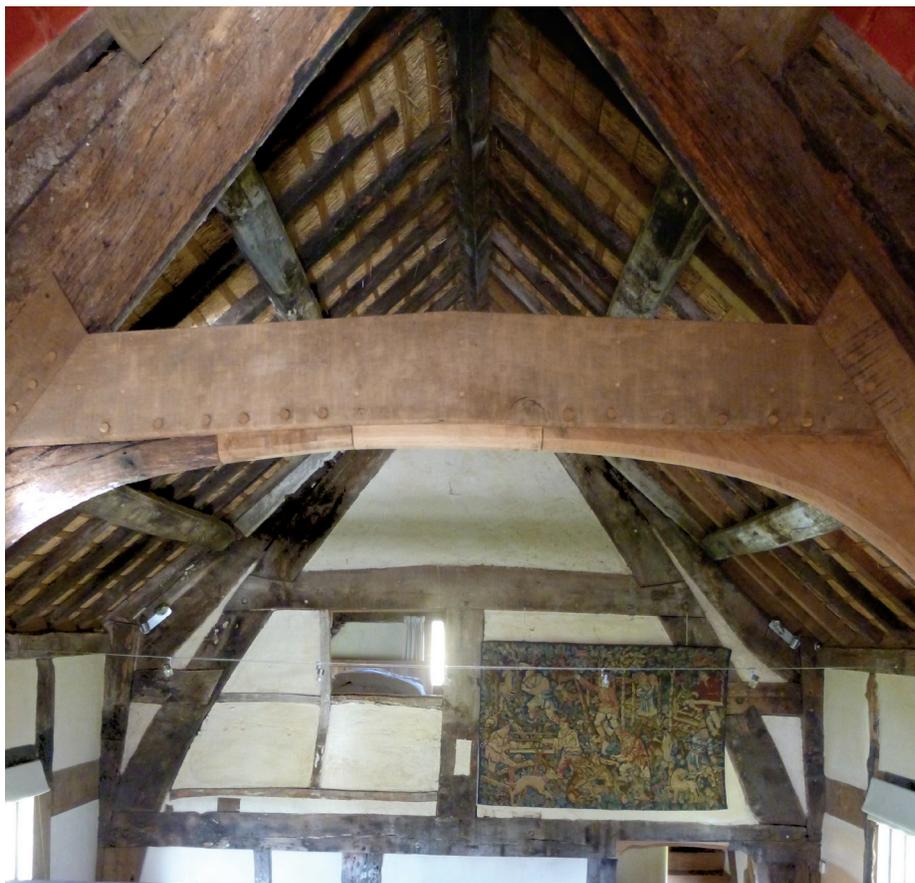
Fig. 10. Hacton Cruck Hall, interior view of central hall with bedroom beyond showing unlined thatch roof, 2015.

$\text{m}^3/\text{hr}/\text{m}^2$ . One area responsible for these high infiltration rates has already been identified, that of the junctions between panels and timber and between those timbers themselves. However, a much more significant element contributing to this lack of air-tightness is the unlined thatched roof (Fig. 10). Thermography of this element clearly showed the difference between the unlined and the lime-plastered roofs at either end of the building.
