# Assessment of Earthquake Damage at the Washington National Cathedral

Matthew C. Farmer  
Kelsey E. Sheridan  
Jacqueline Devereaux

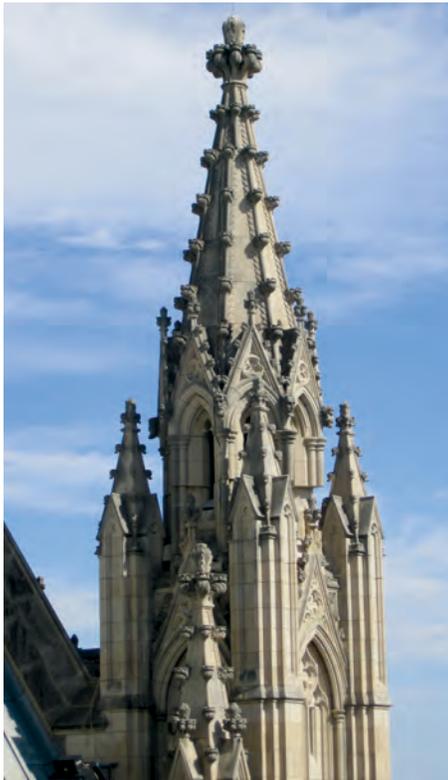
Fig. 1. The Washington National Cathedral, constructed 1907–1990, 3101 Wisconsin Ave NW, Washington, D.C. 20016.

An earthquake on the East Coast of the United States is not an event to which most people would have given much thought prior 2011. But on August 23, 2011, the United States Geological Society recorded a 5.8Mw (moment wave) earthquake with its epicenter in Mineral, Virginia, 84 miles southwest of Washington, D.C. This event affected numerous structures in the area, many of which were registered historic places and landmarks or were constructed using historic materials and methods. Many more unreinforced masonry structures were damaged than modern buildings constructed of concrete or steel. The Washington National Cathedral, perhaps the largest unreinforced masonry structure in the Washington, D.C., area, suffered significant damage (Fig. 1).

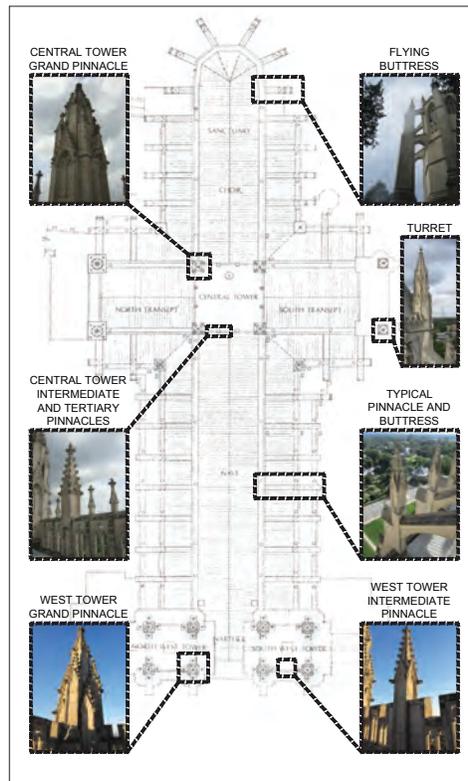
Fig. 5. Plan showing damage distribution.

As illustrated in Figure 5, the damage documented was further sorted into three categories based on the severity of the damage and on the extent of in situ stabilization and repair or removal and reconstruction that was required.

The first category of damage (shown in green in Figure 5) was identified as “no damage”; this term identified those areas where no visible damage was observed and therefore did not require any scaffolding or similar means of access for repair. The second category (shown in orange) was identified as “minor damage”; it consisted of limestone elements that had visible damage at the exposed surfaces of the stone but remained materially intact and fully engaged to the structure. Repair of these elements, which in several locations included surfaces and features that did not contribute significantly to the overall architectural expression of the cathedral, could be undertaken on a more voluntary basis as funding became available. However, mobilization and erection of pipe-scaffolding or similar equipment would be required to access these locations.

The final category (shown in red) was identified as “major damage” and included missing or otherwise visibly unstable elements that remained a potential fall-hazard or damage considered to be structurally insignificant but visually important and therefore in need of more immediate repair. Areas in this category required pipe scaffolding and/or the use of mobile cranes and hand-operated block-and-tackle devices to facilitate the removal, replacement, and resetting of large pieces of stone.

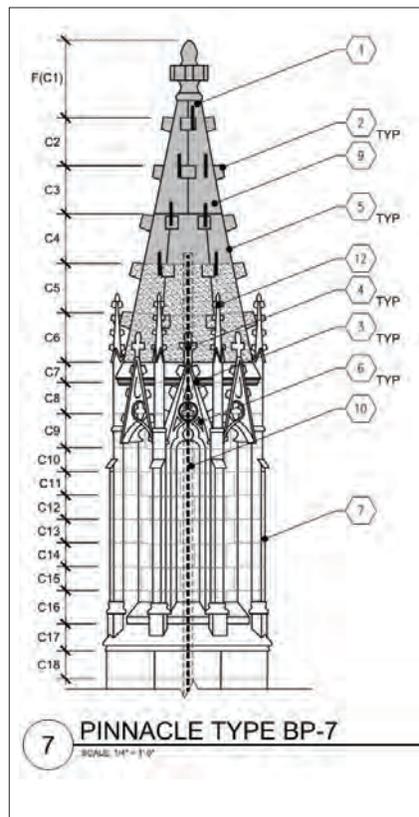
Once the initial cathedral-wide damage assessment was completed in 2012, each damaged stone could be classified by the type of damage, the extent of damage, and the location of the damaged stone (Fig. 9). This information was critical not only in developing preliminary cost estimates for the individual repairs but also in determining the extent and breadth of the restoration required and the types of equipment necessary to reach each damaged stone. With a project of this scale and architectural complexity, one of the principal cost drivers was creating the access to implement repairs. Decisions about using fixed scaffolding, mobile cranes, a tower crane, swing stages, or any combination of these access methods had a significant impact on cost, as well as on the sequencing of the repair work. The ultimate goal was maximizing efficiency and minimizing project duration.

Fig. 9. Damage legend showing typical damage nomenclature generated after cathedral-wide assessment.
