Architectural Terra Cotta

EDWARD GERNS AND RACHEL WILL

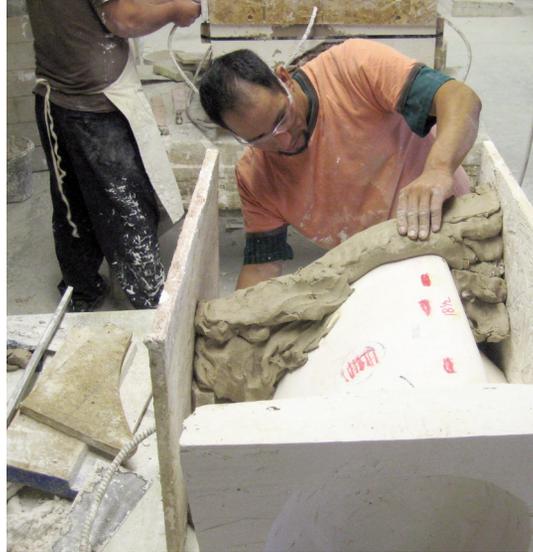
Fig. 1.
Hand-packing clay into a plaster mold at Gladding McBean factory in Lincoln, California, 2014. All photographs by Edward Gerns..

then glazed and fired (Fig. 1). Today there are only a handful of terra-cotta manufacturers in the United States and Western Europe, and each employs at least one of five methods of terra-cotta fabrication, including hand pressed, extruded, slip cast, ram pressed, and hand sculpting. Each method has advantages and limitations.

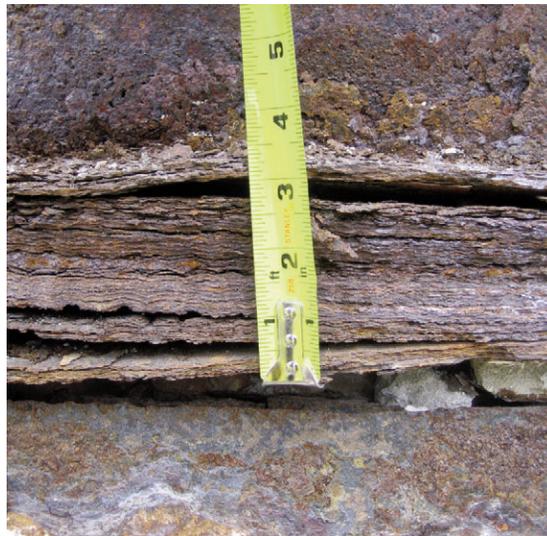
Fig. 5.
Roanoke Building,
Chicago, 1915 and 1925,
corroded beam flange at
37th floor, 2005.

which occupies four to ten times the volume of the

uncorroded steel (Fig. 5). As a result, an understanding of incorporating non-corrodible metals or protecting ferrous metals was recognized.

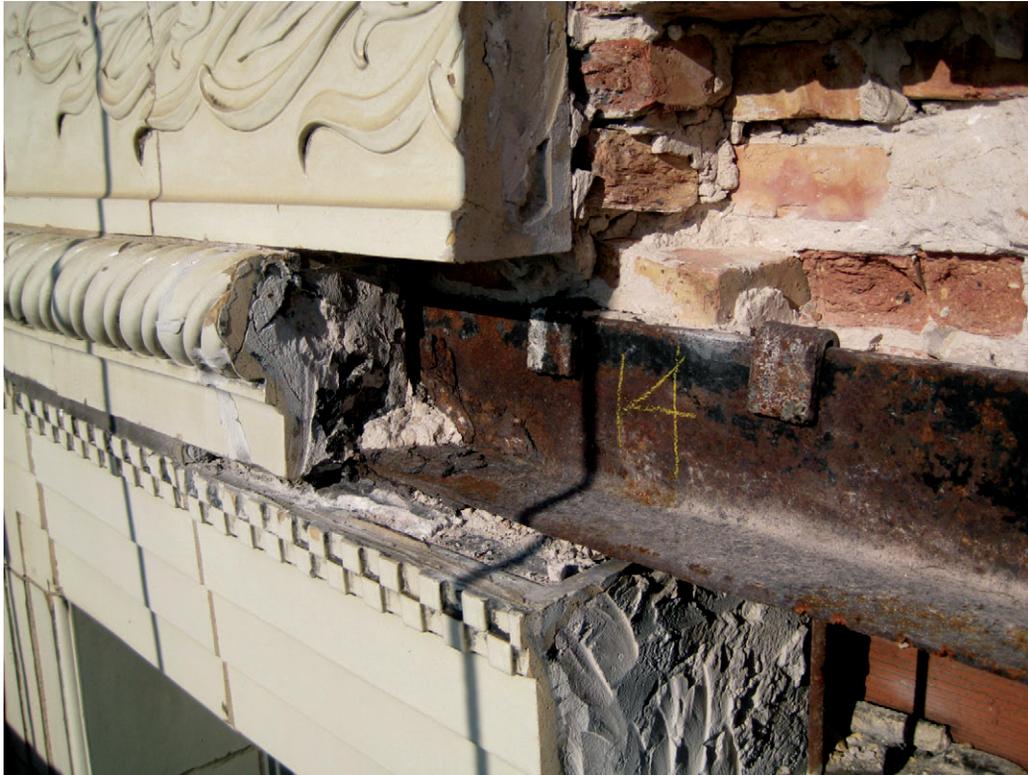
Fig. 6.
New York Life Building,
Chicago, 1889, terra-cotta
lintel installation, 2013.

Remove, repair, reinstall. To address the cause of the distress in terra-cotta cladding, it is often necessary to remove existing material to repair substrate conditions (Fig. 6). Distress in terra cotta is often misunderstood and assumed to be a function of terra cotta not being a durable material. In reality, this is rarely the case. Removing distressed units to expose substrate conditions is certainly more invasive than the in-situ repairs described above, but removal is frequently necessary to treat corroded steel, to reinstall displaced units, or to repair cracked units that should not or cannot be effectively pinned in situ. When units are removed to repair cracks, incorporating mechanical anchorage, specifically pins or other means, along the cracked surface will provide additional strength to the repair.
