Fabricating and Installing Side-Lap Roof Shingles in Eastern Pennsylvania

JAMES HOUSTON AND JOHN N. FUGELSO

In order to restore some of Pennsylvania's historic buildings, the authors are recovering a lost trade practice.

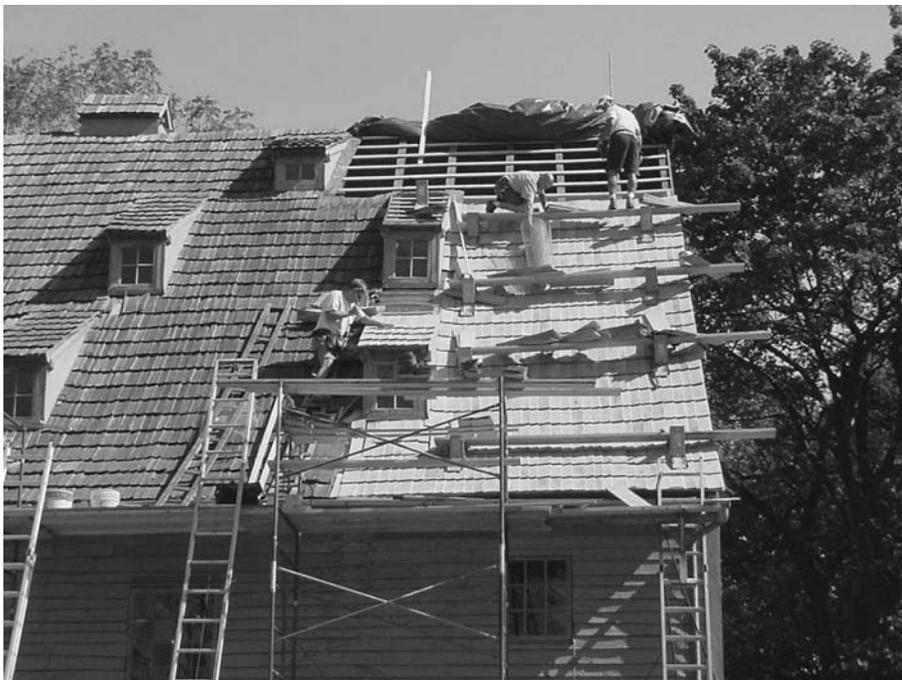
Fig. 1. The layout of side-lap shingles makes it relatively easy to work to a vertical edge. Nineteen-year-old western red cedar shingles are being replaced with handmade red oak shingles at the Saal, or meetinghouse, at Ephrata Cloister. Because the courses of side-lap shingles are not staggered, the roofers are able to work to a straight, vertical edge from the eave to the ridge of the roof, making it much easier to tear off and replace roofing on buildings of this size. All images by the authors.

cal and Museum Commission sites and other public venues and have trained roofing contractors to install side-lap shingles (Fig. 1). In so doing they have tested materials, traditional tools, folklore, and their own ideas. Working from and expanding upon the foundation of research conducted by Robert C. Bucher in the 1960s, the authors have recovered an important traditional craft and trade practice.¹ This article highlights that craft and the venues where it has been applied. A glossary of relevant terms appears at the end of the article.

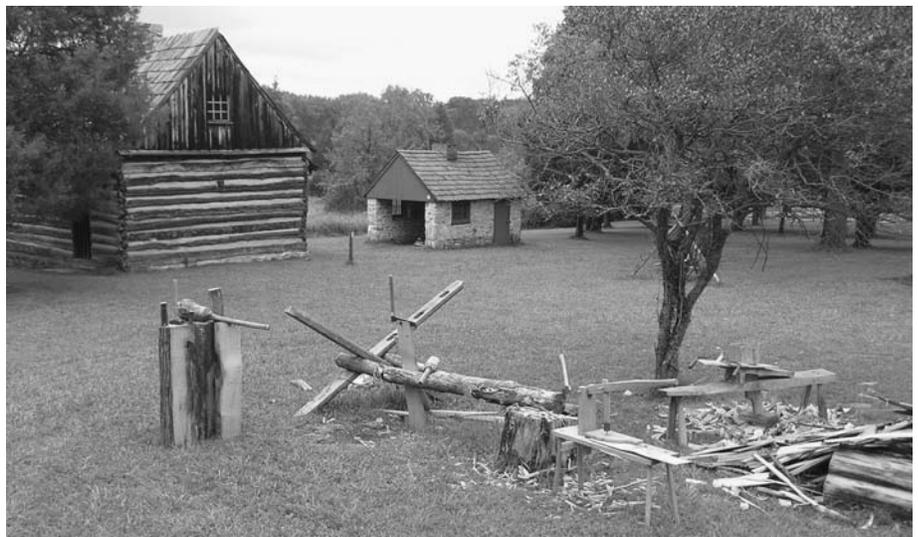
Fig. 3. An array of tools used to make shingles, left to right: wedges and a small sledge; a maul and gluts, on a halved shingle log; riving brake with a shingle bolt, mallet, and froe; hole punch with a shingle under the retainer, ready to punch; a shaving bench and drawknife with a shingle clamped under dumb head; and the scrap pile. Bertolet House, the larger log building in the background, was reroofed in 2007.

drawknife, nail hole punch, sorting bench, and clamps (Fig. 3). The sledgehammer should weigh 4 to 8 pounds, the exact weight depending on the strength of the user; it is used for driving the steel wedges into the log. The root maul is used to drive gluts, simple wood wedges that are 4 to 6 inches thick (driving a glut with a steel hammer will shatter it). Gluts can be made from whatever wood is at hand; dogwood, sycamore, elm, and locust make durable gluts. The gluts are driven into a crack started by the steel wedges, which are too small to drive the halves and quarters of a large log apart. Steel wedges are necessary for the initial split.

The froe mallet should be light enough to use comfortably but heavy enough to drive the blade of the froe into the shingle bolt. A bolt is one-eighth to one-sixteenth section of a round log. Hickory is a good wood for mauls and mallets; the lowest part of the stem, including the root cluster just below ground, is used for both.

The shingle brake is a simple vise used to hold the bolt when riving it into shingles. A tree crotch makes the traditional shingle brake; ash is the best choice because of its narrow crotches (25-degree inside angle).

The shaving bench is a simple foot-actuated clamp used to hold the shingle when working with the drawknife. The shaving bench needs a workspace behind the dumb head (clamping head) slightly more than half as long as the shingle, to support the shingle and prevent the drawknife from skipping when working the shingle. Although many antique drawknives survive, the authors have not found one that can be positively identified as having been used specifically for shingle making. However, based on experience and experimentation, the best results are achieved using a drawknife that has a blade about 10 inches wide, with handles 7 inches from the blade. The overall length of the drawknife used for Pennsylvania Historical and Museum Commission projects is 24 inches. The angle of the hand grips, which are pitched below the plane of the blade, allows the shingle maker to use full arm and back strength while slicing and cleaving the wood.

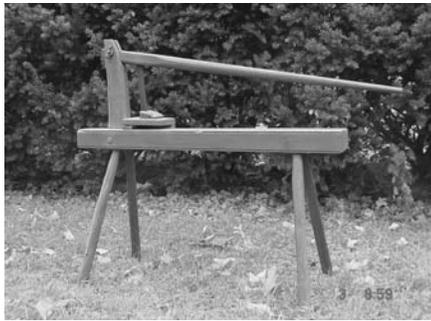
Fig. 5. An antique hole punch from the collection of John Fugelso. A hole punch is used to make the nail hole in each shingle.

Next, shingle stock is moved to the hole punch (Fig. 5). The hole punch is mounted on a bench or a plank and has a retainer to hold the shingle down when the hole-punch bit is withdrawn. The retainer is supported on two strips of wood mounted at right angles to each other. These strips index the location of the nail hole. The retainer also serves as a thickness gauge; if the butt will not slide under the retainer, it goes back to the shaving bench. The shank of the nail-hole bit should be strong enough to prevent its bending, and the holes

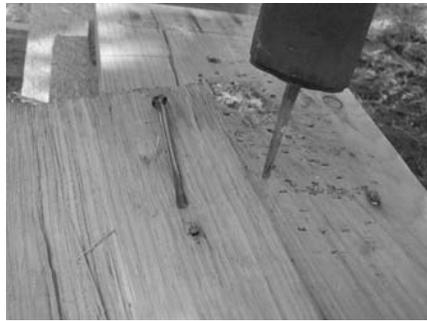
Fig. 6. A spade-pointed nail and freshly punched shingle; the working end of a hole punch is at the right.

should be punched when the shingle is green. The punch has a sharp edge that cuts across the grain and matches the width of the shank of the shingle nails (Fig. 6). Punching in this way relieves splitting forces in the shingle and leaves severed fibers in the hole, which form a tight seal around the nail when it is inserted later.

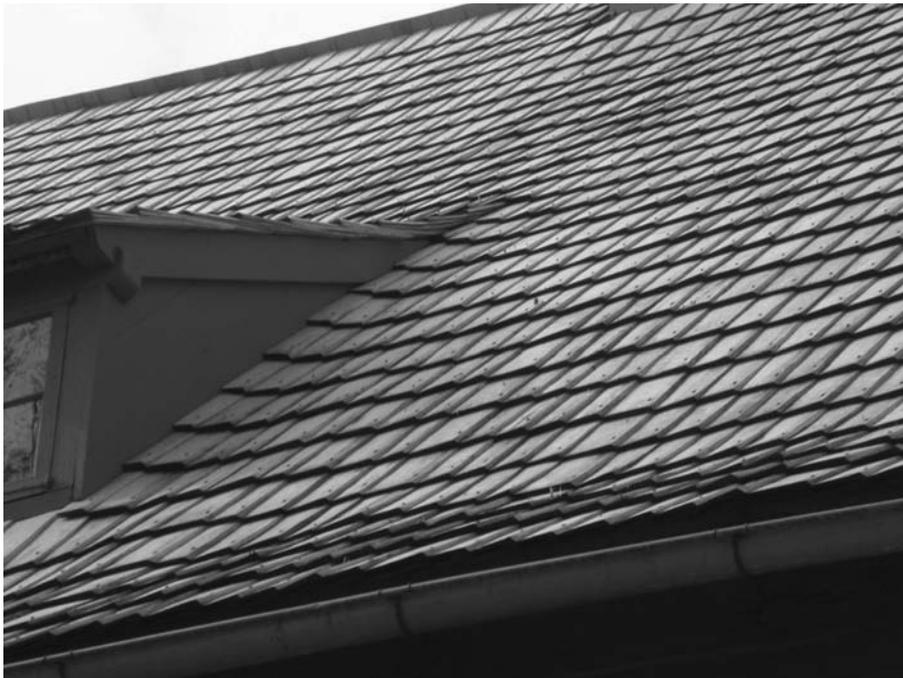
Fig. 9. The Saron, Ephrata Cloister, 2005. Each row, running vertically, contains shingles of like width. Courses run horizontally. Also visible are the kick at the eave and the upward flare of the roof at the side of the dormer created by a tapered fillet board. There is no metal flashing.

Side-lap shingles are applied in two orientations, courses and rows. Courses are horizontal, running parallel to eave and ridge, and rows are vertical, extending from the eaves to ridge. Shingles in a course will vary in width across the rows. All shingles in a row, however, must be the same width, because they will lap over the next row (Fig. 9). The width of rows should be alternated so that not all the shingles of any given width are used at one time. At some point the distance to the gable end must be calculated against the width of the shingles remaining. Row width will have to be adjusted as the installer gets close to the gable end so that the last row is not too wide or too narrow. At this point it seems that 4 inches should be the minimum shingle side exposure at the gable end.

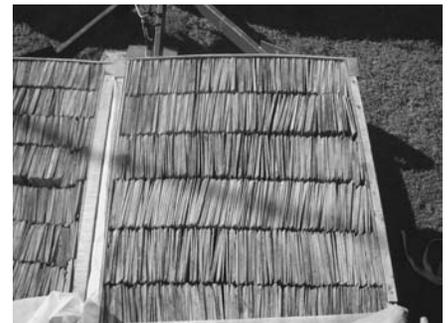
Fig. 10. A delivery crate packed tightly with banded bundles, arranged by size, of new red oak shingles for use at the Wright's Ferry Mansion, in Columbia, Pennsylvania.

stored and shipped by stacking in a large plywood crate, which helped to prevent drying out (Fig. 10).³ However, the carpenters installing the shingles said that the shingles on the top of the pile had dried out and cracked when nailed. They were planning to soak the shingles to prevent cracking. All shingles were being hole punched on the job site and were installed without tar paper between courses. Since 2003 the overhanging tree limbs have been cut back to allow more light and air circulation. In 2007 the roof remains in good condition.
